To: Larry Coulson  
From: Rich Orr *R. Orr*  
Subject: ODH SITUATIONS ENCOUNTERED IN ACCELERATOR DIVISION

ODH SITUATIONS ENCOUNTERED  
BY THE ACCELERATOR DIVISION

SIMULATION OF ACCIDENT INVOLVING THE RELEASE  
OF LIQUID HELIUM INTO THE MAIN RING TUNNEL

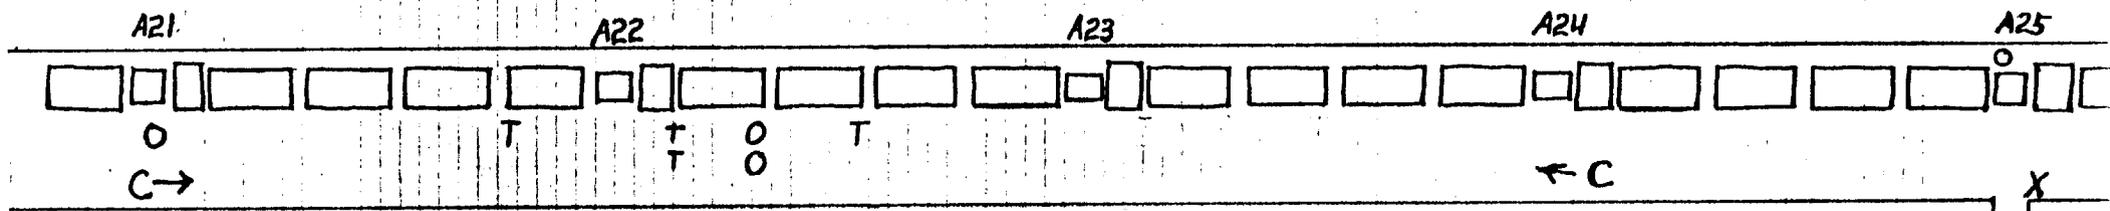
Fig. 1

Figure 1 shows the location of the instrumentation in the immediate vicinity of A-22. There were four types of instruments used to measure the effects of the test.

1. Television Monitors: Three cameras were placed in the tunnel at the locations shown in Fig. 1, each about two feet off the floor. Cameras one and two were video taped, but unfortunately only the video tape of camera one was usable, due to instrument failure or operator error. In addition, there was audio at A-22. The impressions are discussed in Section III.

3. Four temperature monitors were used as shown in Fig. 1. These were  $100\Omega$  platinum resistors, read out on a chart recorder at the A-2 Service Building. The temperature coefficient of the resistors was  $0.385 \Omega/^{\circ}\text{C}$ ;  $R = 100\Omega$  at  $T = 0^{\circ}\text{C}$ . The estimated reading uncertainty of the data is 50 mvolts, corresponding to a temperature uncertainty (relative) of  $\sim 3^{\circ}\text{C}$ . Figure 3 shows the time response of temperature. We believe that the resistor at A-22-2 was offset by about  $10^{\circ}\text{C}$  since the quiescent temperature in the tunnel was close to  $20^{\circ}\text{C}$ , not  $11^{\circ}\text{C}$  as shown.

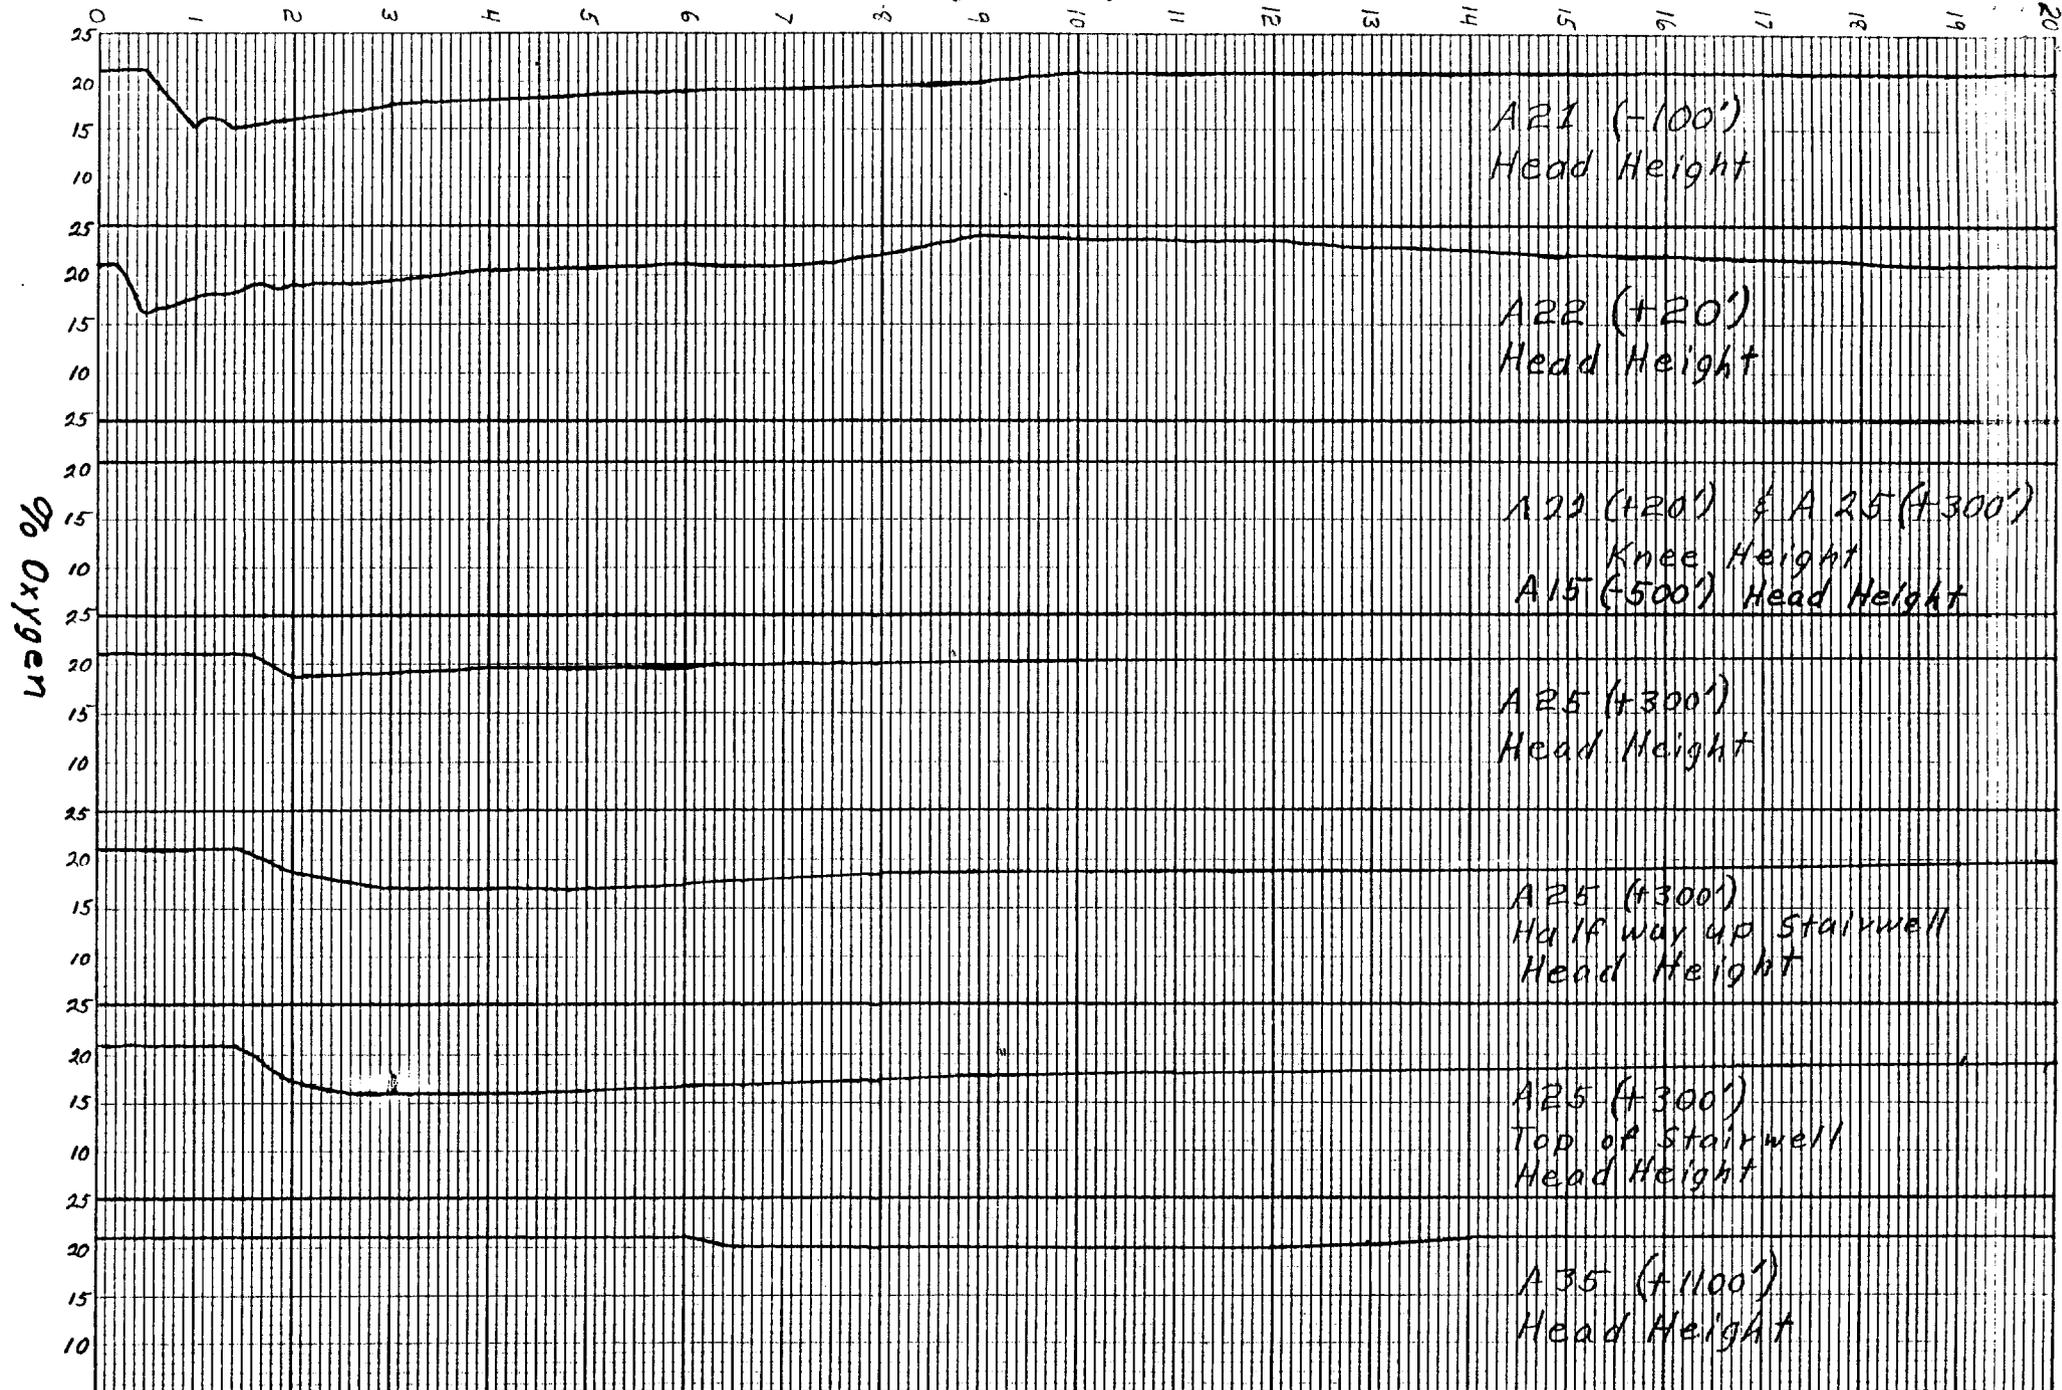
Fig. 2

1. From the oxygen analyzers, it appears that the helium gas traveled in bulk at about 200 feet/min. The lowest recorded value of oxygen was 15% at A-21 (100' upstream) and 16% at A-22 and at the top of the A-25 stairwell. Because of possible calibration problems due to moisture, it is probable that the value at A-22 at head height was considerably lower than the recorded 16%.
2. The most striking result, it if is true, is the absence of oxygen depletion at A-22 (20' downstream) at knee height. This analyzer was tested the next day and appeared to be in working condition. If that is so, it means that staying close to the floor, and only 20' from the blowout is quite safe, as

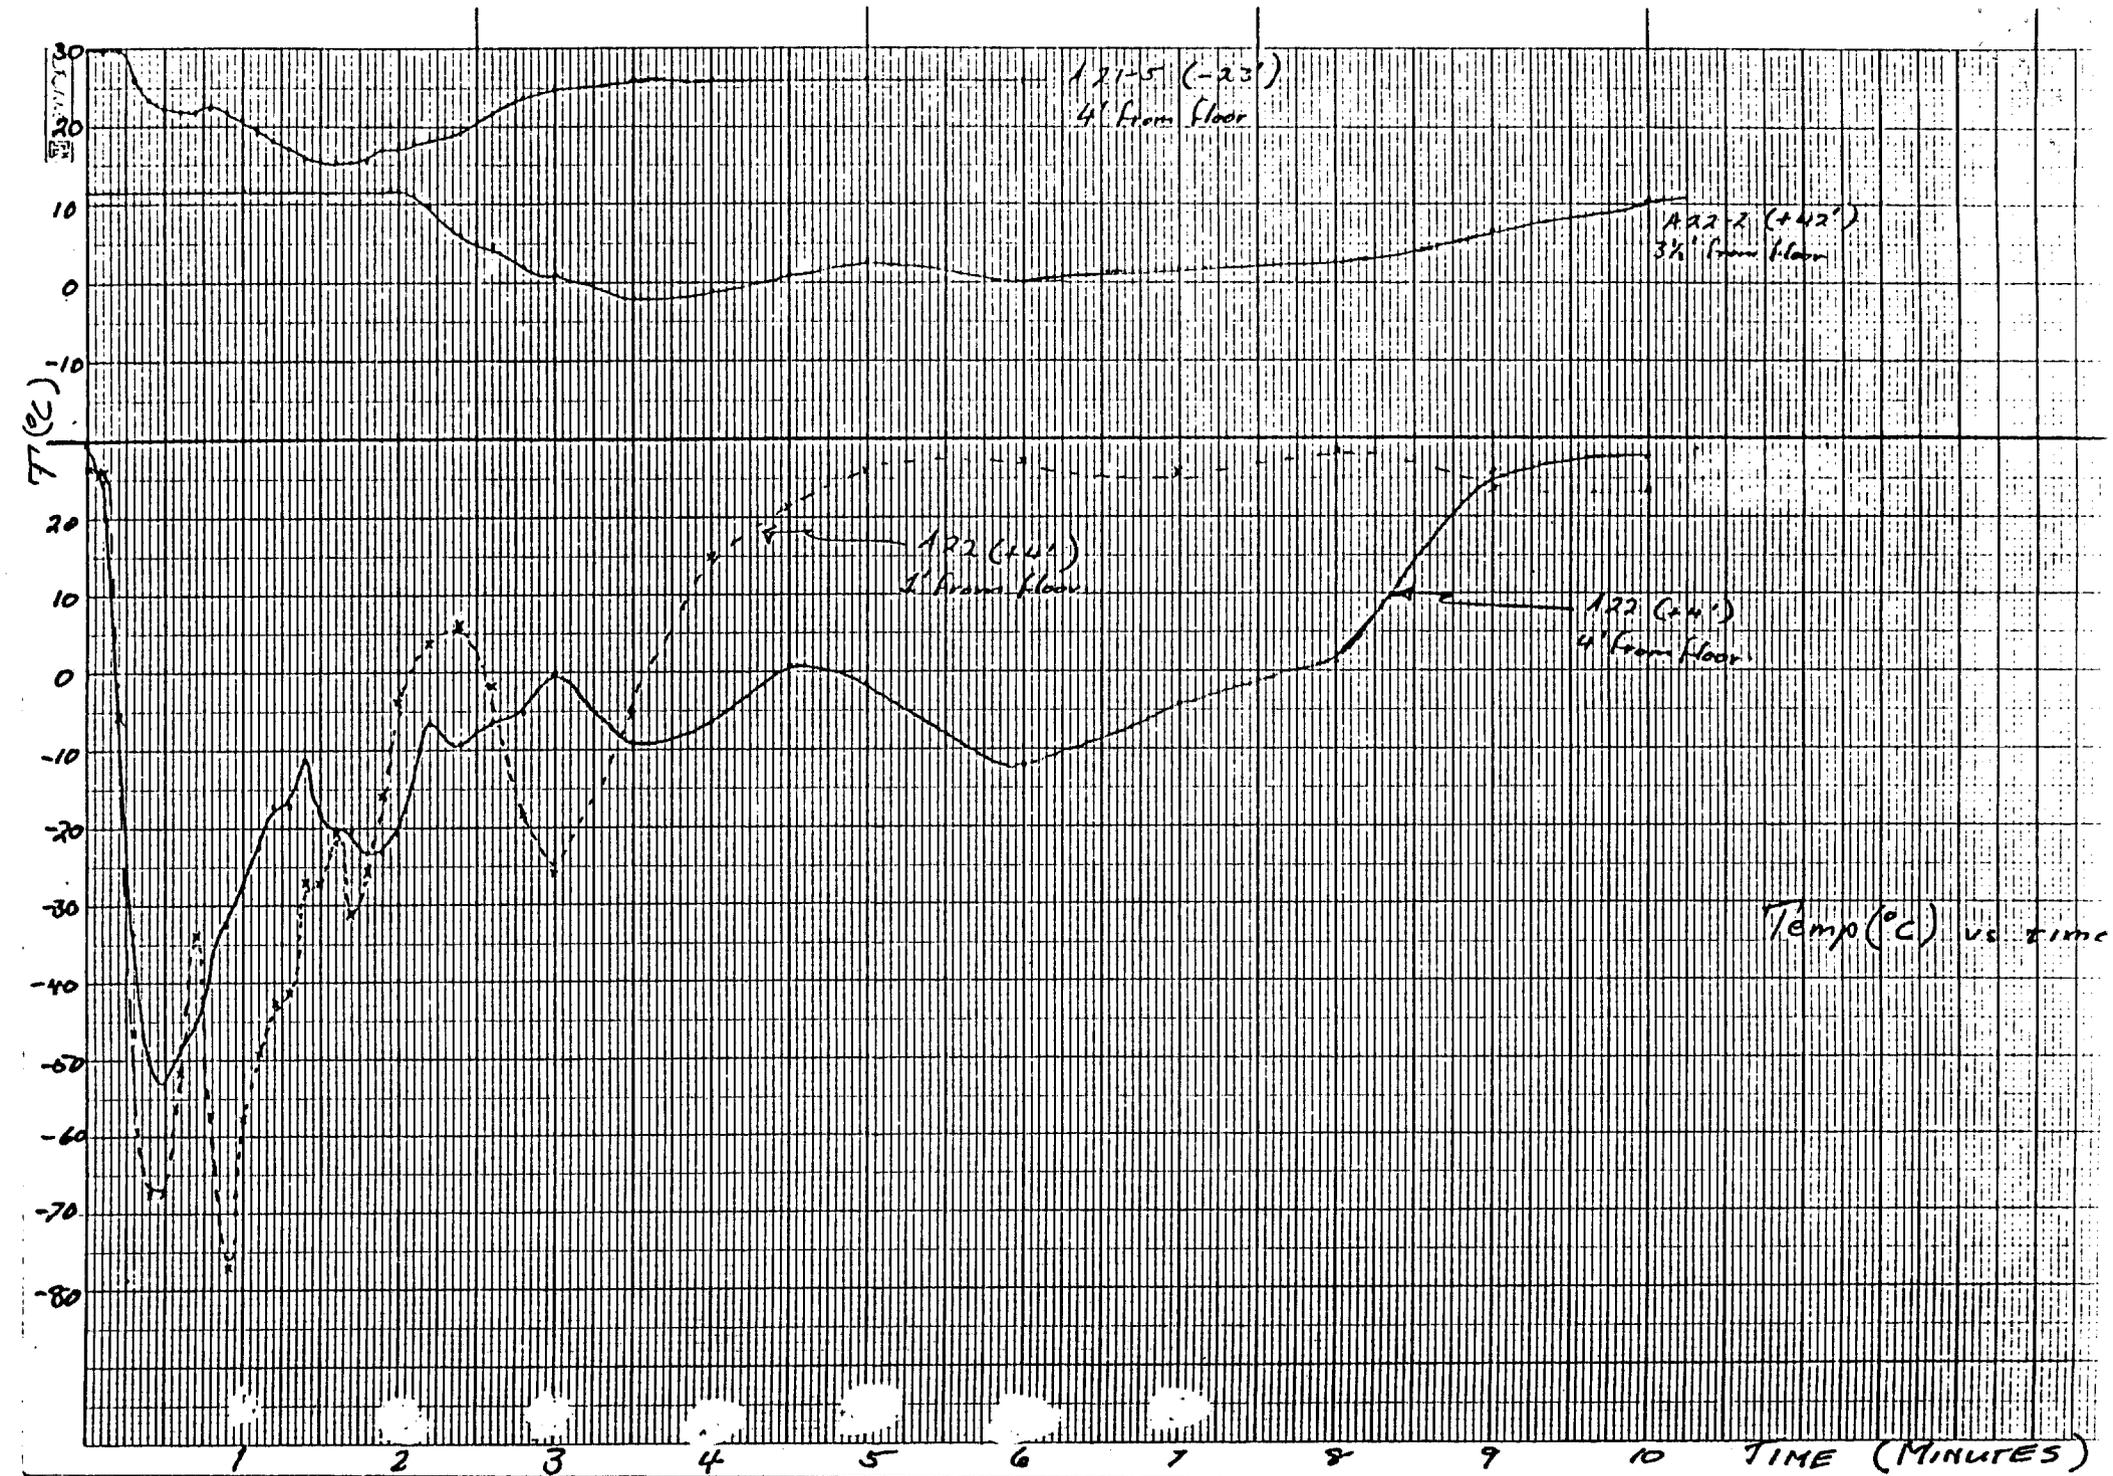
Fig. 3

1. Clearly, the most spectacular result is the low temperature in the vicinity of the spill. The temperature fell very fast to  $-50^{\circ}\text{C}$  ( $-75^{\circ}\text{F}$ ) at four foot height, and  $-70^{\circ}\text{C}$  ( $-95^{\circ}\text{F}$ ) at one foot height within 30 seconds. Although the temperature then increased quite quickly, it was still  $-10^{\circ}\text{C}$  after five minutes. It is possible that these temperatures could cause injury, particularly to a person's lungs. At  $\sim -45^{\circ}\text{C}$  lung tissue begins to freeze. (Ref. NASA.)

However, 20 feet upstream and 40 feet downstream, the temperature change was only about 10°C. We believe, as mentioned before, that there was a zero offset problem on the thermometer at A-22-2, but that the change in temperature is correct.

2. The large fluctuations in temperature at A-22 are probably due to turbulence in the tunnel air.

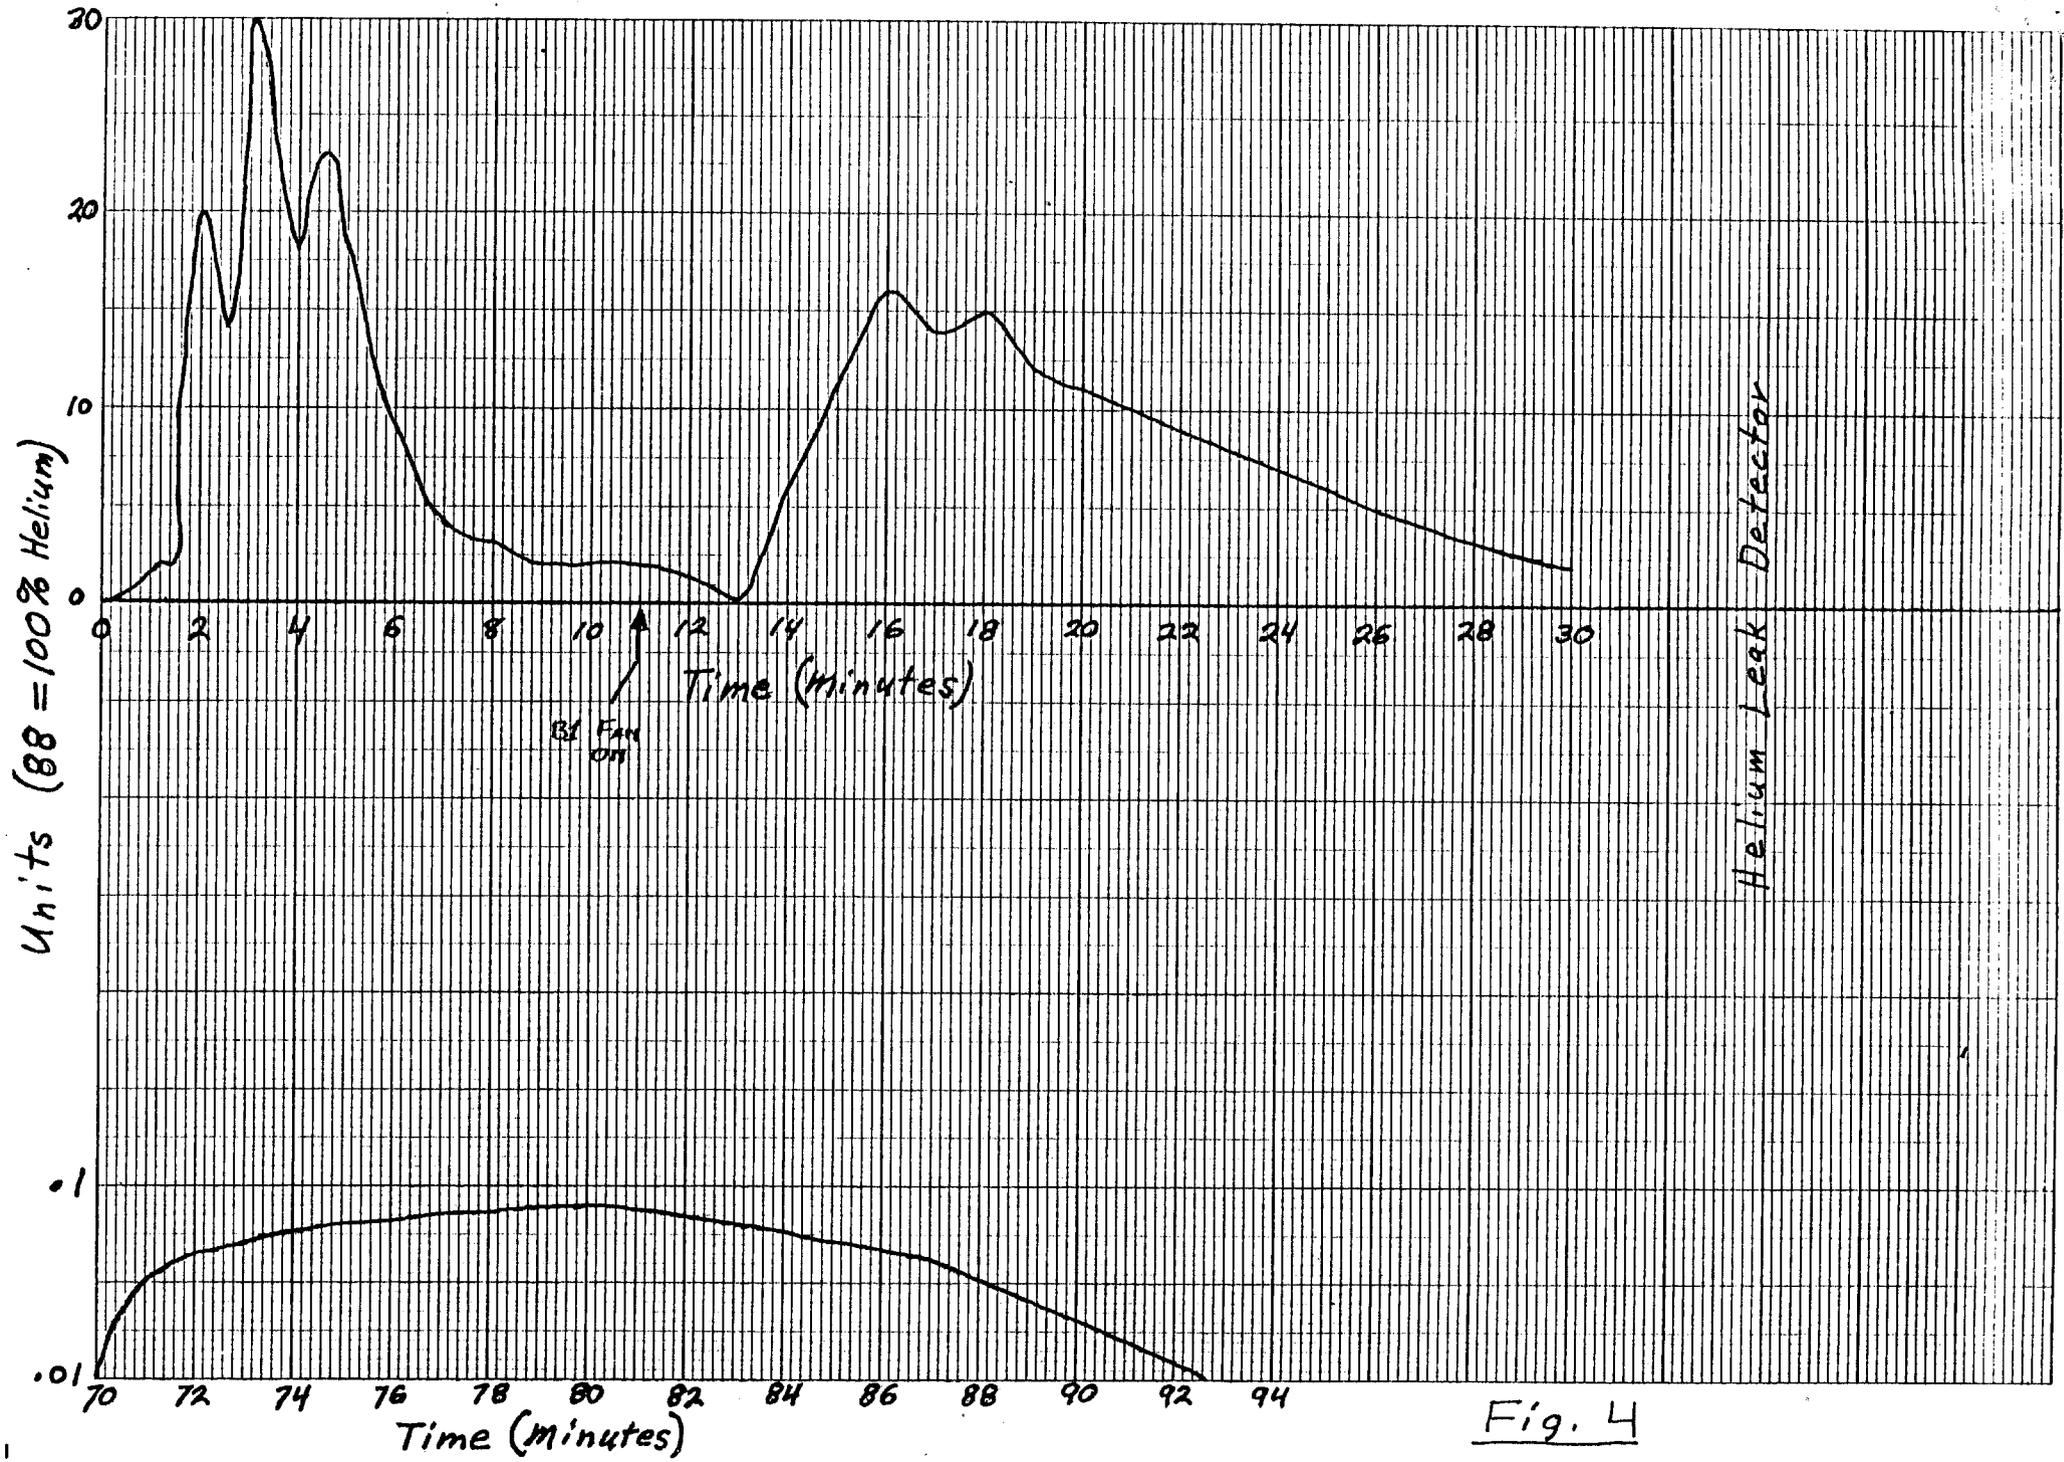
Fig. 4

3. It is interesting to observe the helium leak detector (Fig. 4). It responded roughly on the same time scale as the oxygen analyzer. Shortly after the tunnel exhaust fan was turned on at B-1 location (+11 minutes), the leak detector shows a large response. We believe that this was due to helium being pulled down from the top of the stairwell just past the detector, which was only two or three feet upstream of the bottom of the stair. Also, at +70 minutes, the leak detector shows a sharp upward response, at a level two orders of magnitude less than the initial response. It is possible that this is helium coming around the tunnel due to the natural circulation in the tunnel. A three mile per hour circulation would correspond to about 75 minutes around the tunnel. It is also possible that this is due to some more mundane event; for example, the liquid nitrogen level in the trap going to a low level. Before there was a clear indication of the downward side of the response, the leak detector began to malfunction, probably due to too high a total pressure.

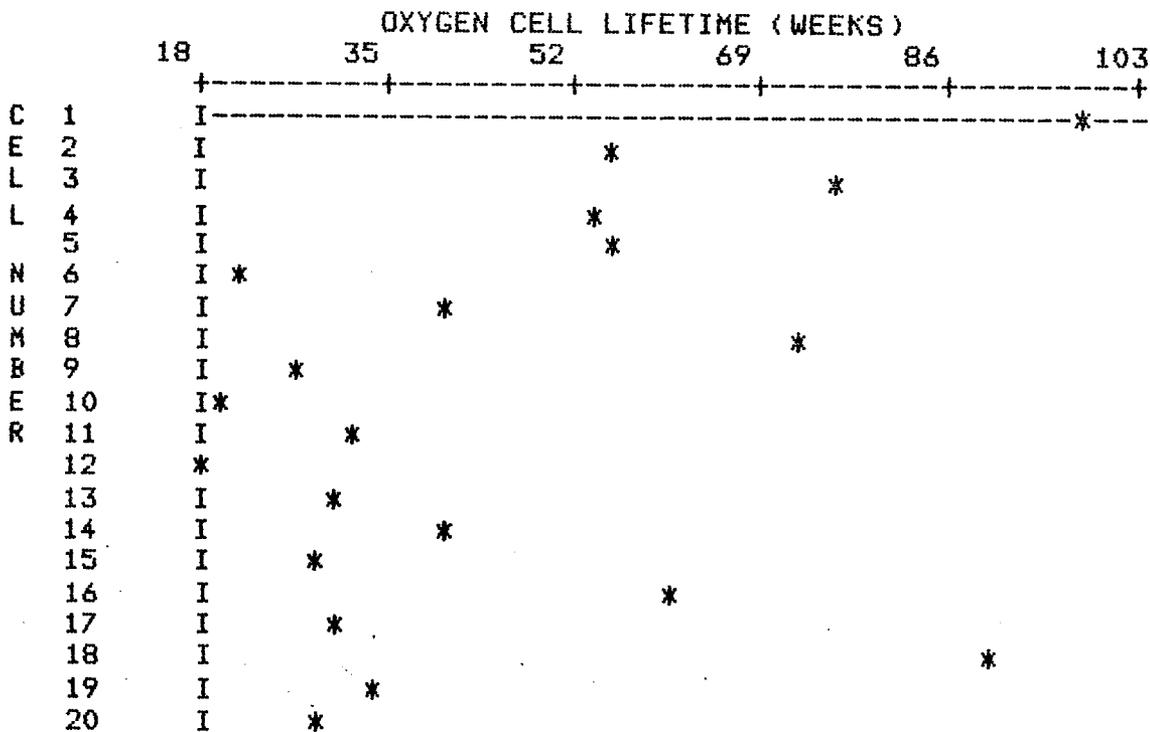
A total of 20 cells have expired with a mean life of 45 weeks. This value is deceptive since the range is very large. We have two cells that have lived up to 90 weeks and a few others that died after only 20 weeks. This characteristic is best indicated by the standard deviation statistic of 23.6. As we increase our sample size over the next year, I suspect that the lifetime of the cells can be characterized as a normal distribution.

It is also worthy to note that the cells that have failed, fail in two ways. Either the output is drastically reduced, or the cells output is erratic; slight movements of the cell cause the output to change. Most cell failures fall into this latter category.
