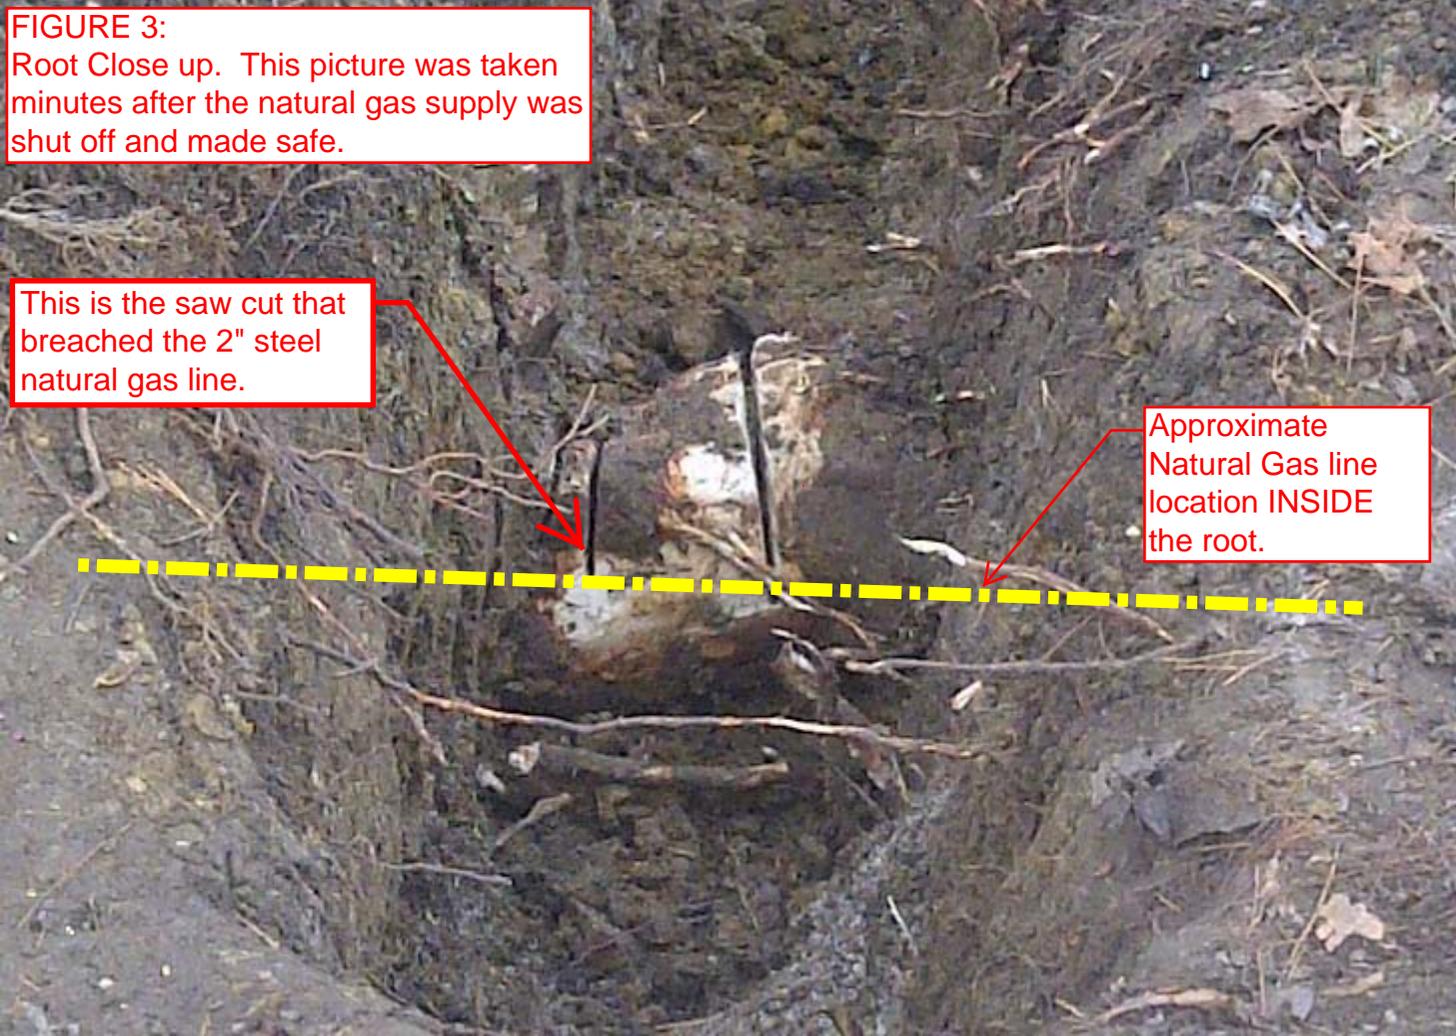
**FIGURE 3:**  
Root Close up. This picture was taken minutes after the natural gas supply was shut off and made safe.

This is the saw cut that breached the 2" steel natural gas line.

Approximate Natural Gas line location INSIDE the root.
