ENGINEERING REPORT

2012 THERMOGRAPHIC SURVEY AND EQUIPMENT INSPECTION

HIGH VOLTAGE MAINTENANCE

April 19, 2012

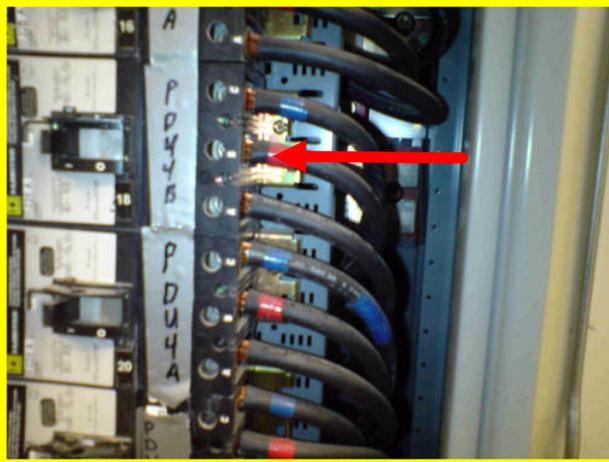
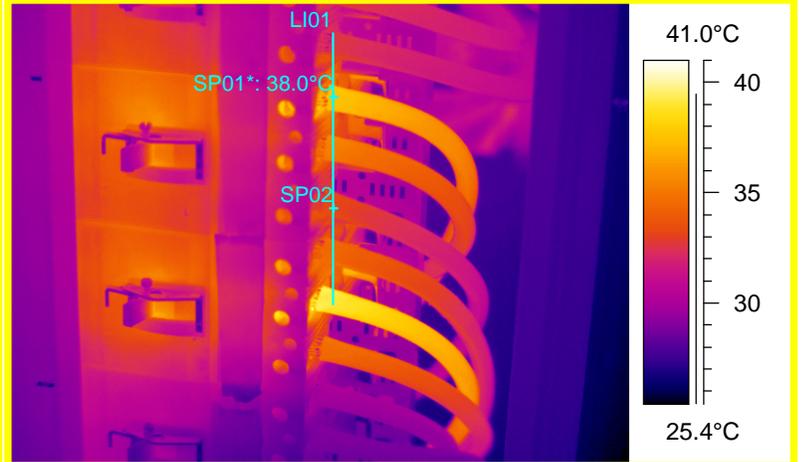
- 1.0 **Building FCC; Lower Level; UPS-PHP-1-01; MCCB UPS PP2-5 &6 and MCCB UPS PP2-7&8** – These breakers are exhibiting an abnormal thermal pattern due to an unbalanced load. We recommend investigation to determine the cause of the unbalance and we recommend distributing the load more evenly.

Label	Value	Diff	Formula
SP01*	38.0°C		
SP02	33.2°C	DI01: 4.80°C	SP01 - SP02

- 1.1 Duct tape affixed to the breakers label them differently than they are labeled on the panel mat as shown in the digital photos on these pages. We recommend determining how the breakers should be labeled and correcting the panel mat or the tape on the breakers. (See Pages 67 to 68)

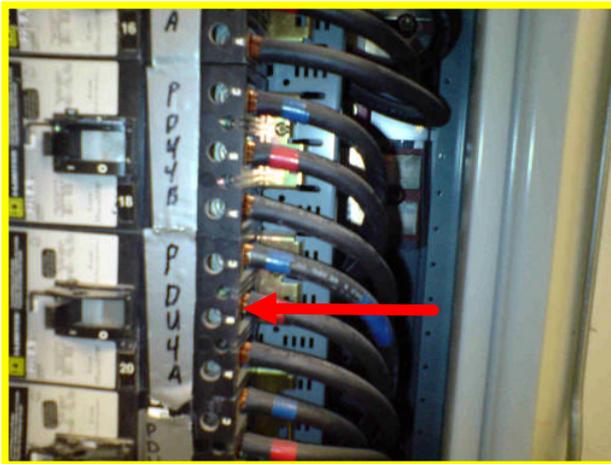
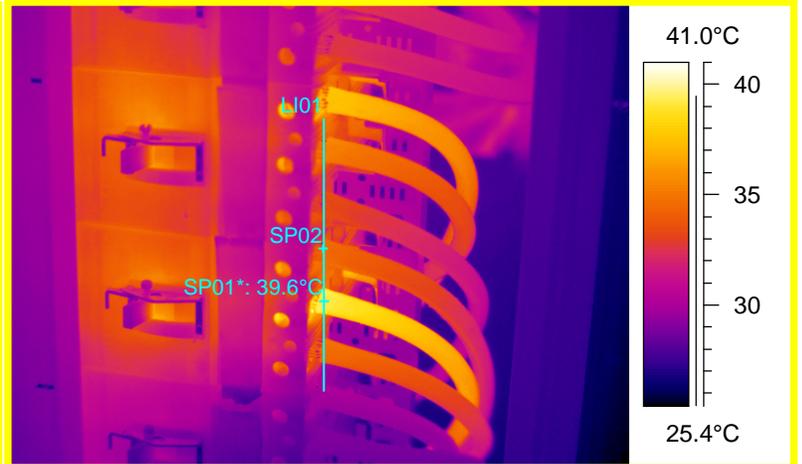
Label	Value	Diff	Formula
SP01*	39.6°C		
SP02	34.1°C	DI01: 5.49°C	SP01 - SP02

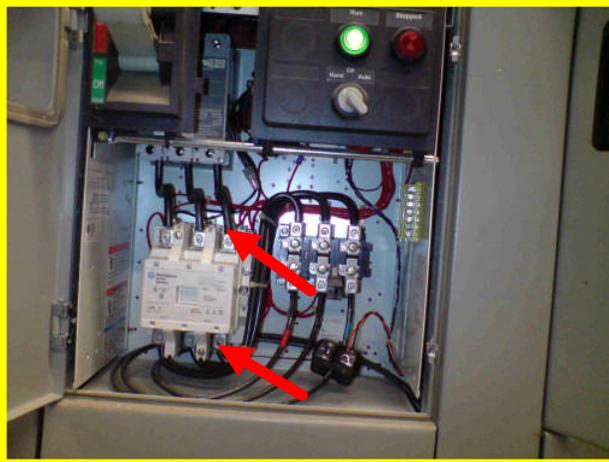
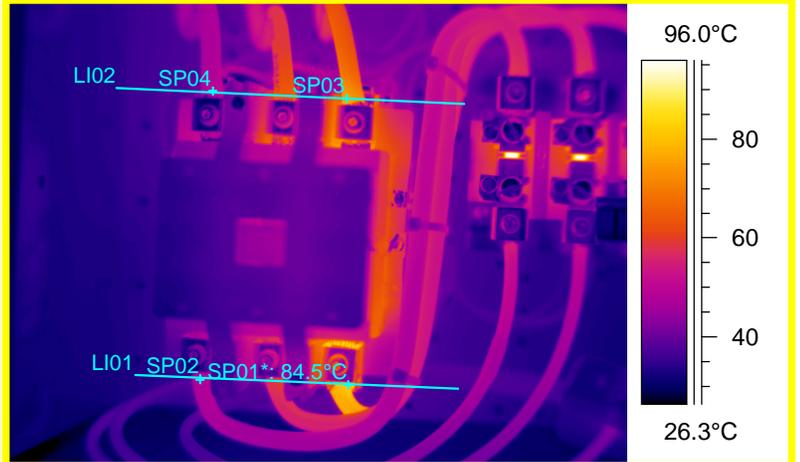
- 1.0 **Building FCC; Lower Level; MCC-BLDG-FCCF; RW-1 Contactor** – C Phase line side and load side is exhibiting elevated temperature. We recommend investigation, re-torquing the connections and measuring contact resistance. (See Page 69)
- 2.0 **Building LCC; Room 107; Panel PP-NL30-1** – There is excessive dust and debris in the bottom of this panel. The contamination of insulation barriers, insulating bushing or conductor surfaces can degrade the insulating or current carrying properties, resulting in premature insulation failure and overheating. We recommend scheduling this panel for maintenance cleaning. (See Page 92)
- 3.0 **Building LCC; Room 107; LP-NL-15B-3A1-10; Circuits 7, 9 and 11** – The conductors for these breakers have exposed copper. We recommend re-terminating these conductors. (See Page 93)

Label	Value	Diff	Formula
SP01*	84.5°C		
SP02	48.1°C	DI01: 36.38°C	SP01 - SP02
SP03	76.3°C		
SP04	49.6°C

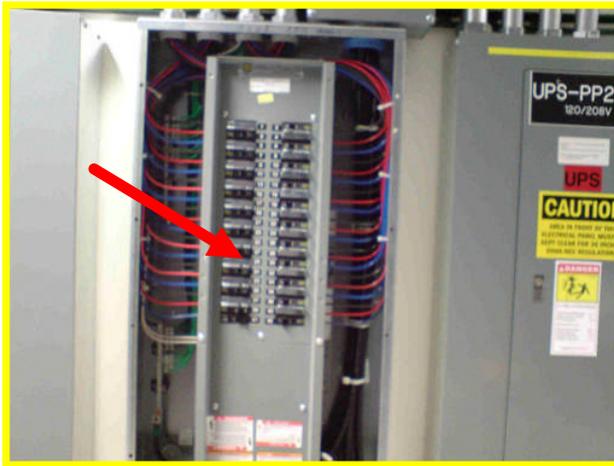
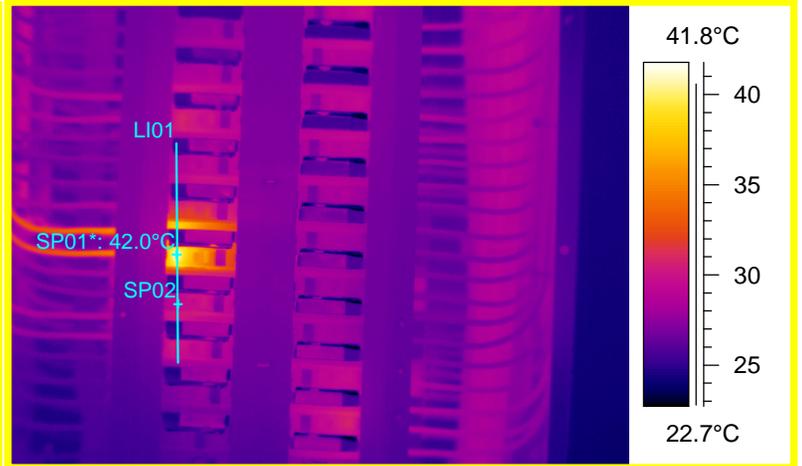
- 1.0 **Building FCC; Floor 2; Computer Room; UPS-PP-11; Breakers 27 and 29** – These breakers are exhibiting elevated temperature when compared to the ambient temperature. The breakers may have a loose connection or may be bad/failing. We recommend investigation. (See Page 70)

Label	Value	Diff	Formula
SP01*	42.0°C		
SP02	29.3°C	DI01: 12.65°C	SP01 - SP02

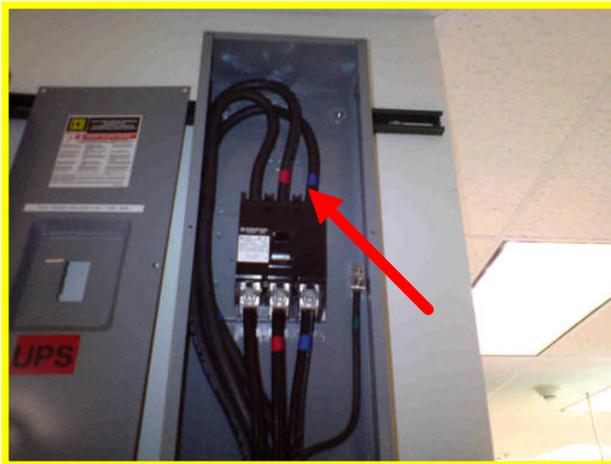
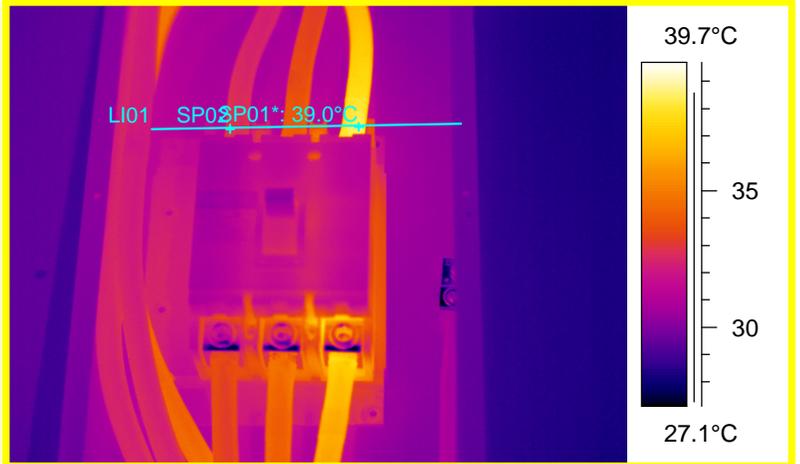
- 2.0 **Building FCC; Floor 2; Computer Room; UPS-PP2-06 CB Disc** -- This disconnect is exhibiting an abnormal thermal pattern due to an unbalanced load. We recommend investigation to determine the cause of the unbalance and we recommend distributing the load more evenly. (See Page 72)

Label	Value	Diff	Formula
SP01*	39.0°C		
SP02	33.0°C	DI01: 5.96°C	SP01 - SP02

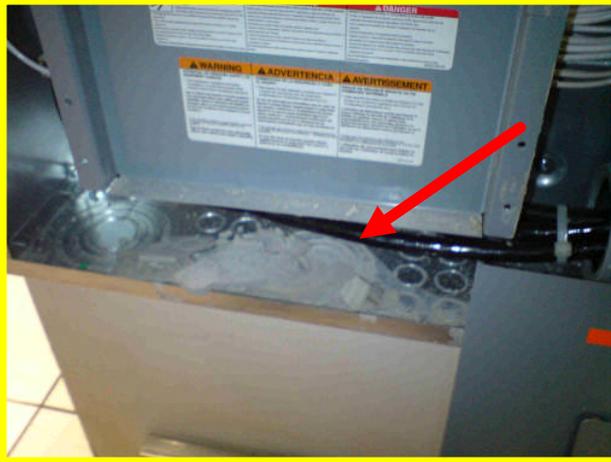
PHOTO # 0642

- 1.15 Building LCC; Room 108; PP-NL-15B-6-45 (See Page 95)
- 2.0 Building FCC; Floor 2; Computer Room; UPS-PP2-21 – Concrete dust and debris was found in the bottom of the panel and was removed. (See Page 73)

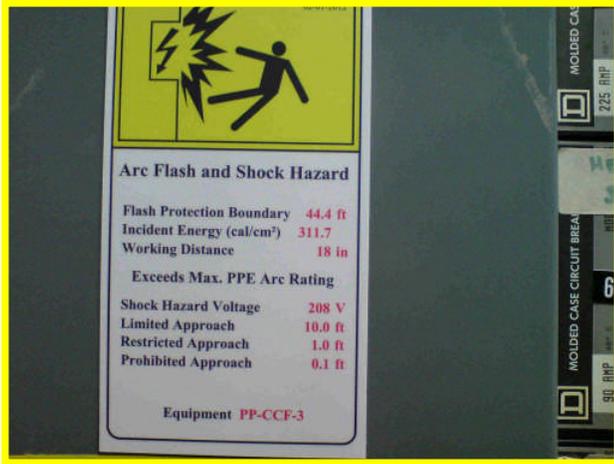
PHOTO # 0629

- 3.0 Building FCC; Floor 3; Fan Room; PP-CCF-3 – It is unsafe to remove the cover from this equipment while energized. A digital photo of the arc flash approach boundary equipment label is shown. (See Page 75)

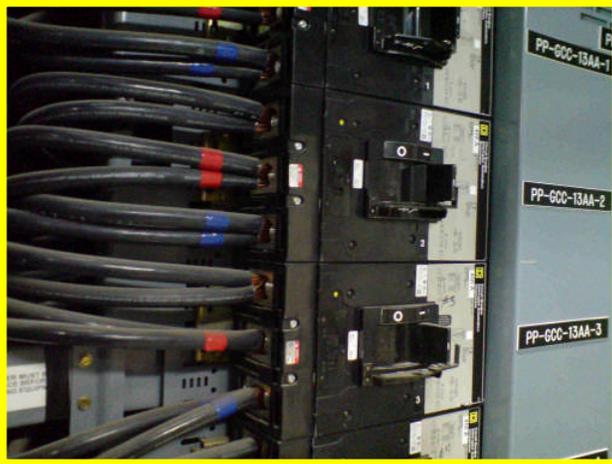
PHOTO # 0615

- 2.0 **Building GCC; Electrical Room A; DHP-GCC-13AA; Breakers PP-GCC-13AA-1 to PP-GCC-13AA-11** – There are two conductors terminated to a lug which is listed for single conductor application on these 11 breakers. The NEC required that listed or labeled equipment shall be installed, used or both in accordance with any instructions included in the listing or labeling. It is recommended that the additional conductors be relocated to separate breakers or single conductor applied at the breaker lug with a splice to connect to multiple conductors. (See Example on Page 80)

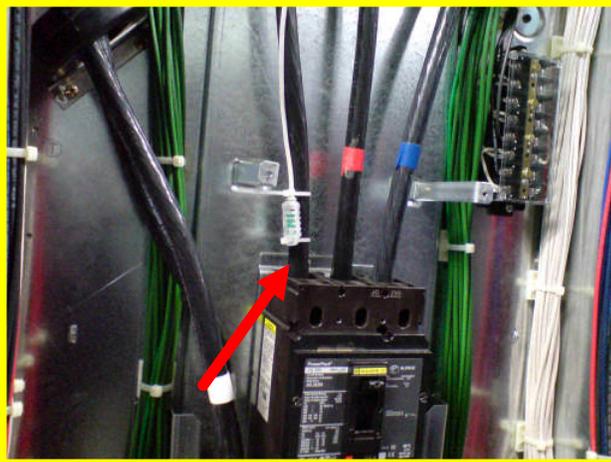
PHOTO # 0621

- 3.0 **Building GCC; Room CRB; PP-GCC-21A-16** – A Phase is exhibiting elevated temperature consistent with a loose or dirty connection. We recommend clean and re-torquing the connection. (See Page 87)

Label	Value	Diff	Formula
SP01*	43.1°C		
SP02	39.7°C	DI01: 3.43°C	SP01 - SP02

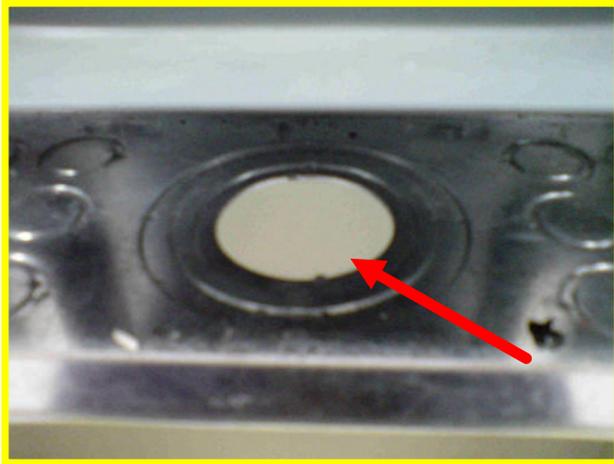
PHOTO # 0622

- 4.0 **Building GCC; Room CRB; PP-GCC-21A-1** – There is an unused opening in this panel. The NEC states that unused cable or raceway openings in boxes and conduit bodies shall be effectively closed to afford protection substantially equivalent to that of the wall of the box. We recommend installing an approved sealing device such as a knock out seal. (See Page 88)

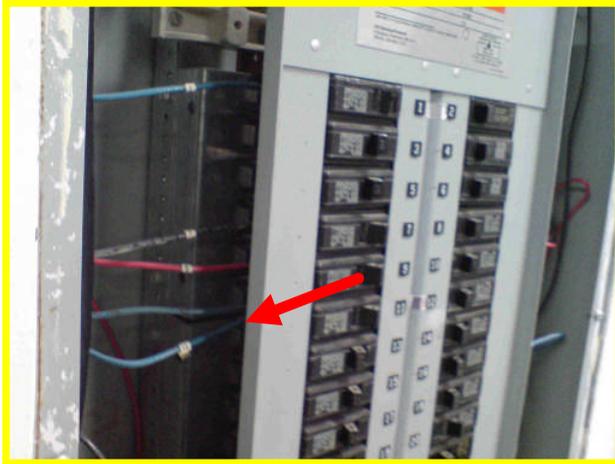
PHOTO # **0597**

- 3.0 **Building LCC; Room 107; Panel PP-NL30-1; Circuit 11** – There are two conductors on this single pole 15 Amp breaker. It is recommended that the additional conductor be relocated to a separate breaker. (See Page 91)

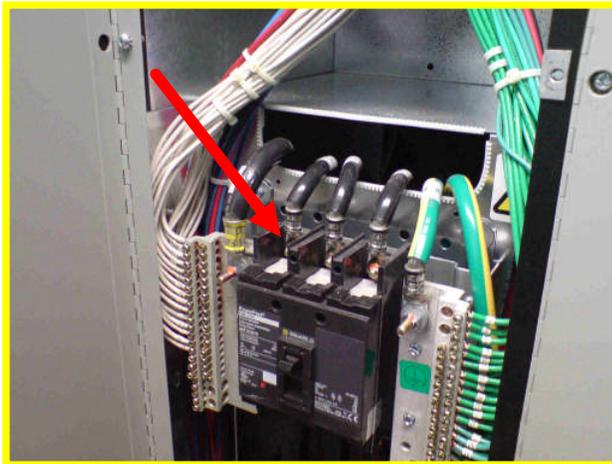
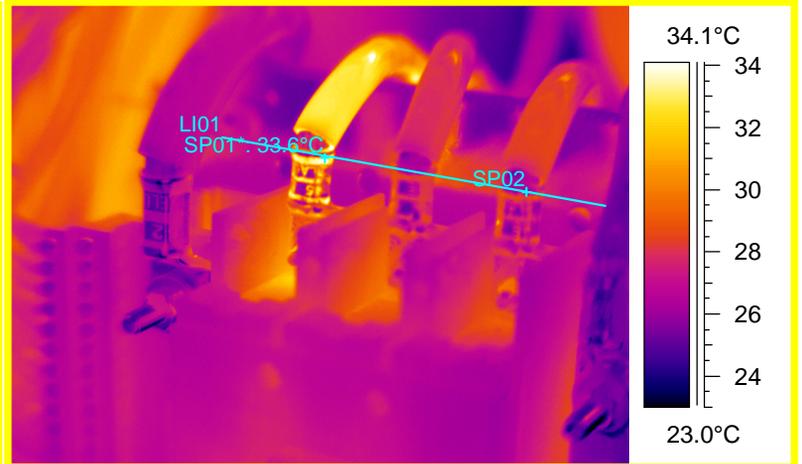
- 5.0 **Building LCC; Room 107/108; PDU-22; PP-NL-15B-22A** -- This equipment is exhibiting an abnormal thermal pattern due to an unbalanced load. We recommend investigation to determine the cause of the unbalance and we recommend distributing the load more evenly. (See Page 96)

Label	Value	Diff	Formula
SP01*	33.6°C		
SP02	25.9°C	DI01: 7.73°C	SP01 - SP02
