FERMILAB
Technical Division
Magnet Systems

Incident Report

IQB310 Failed Tie Plate Welds

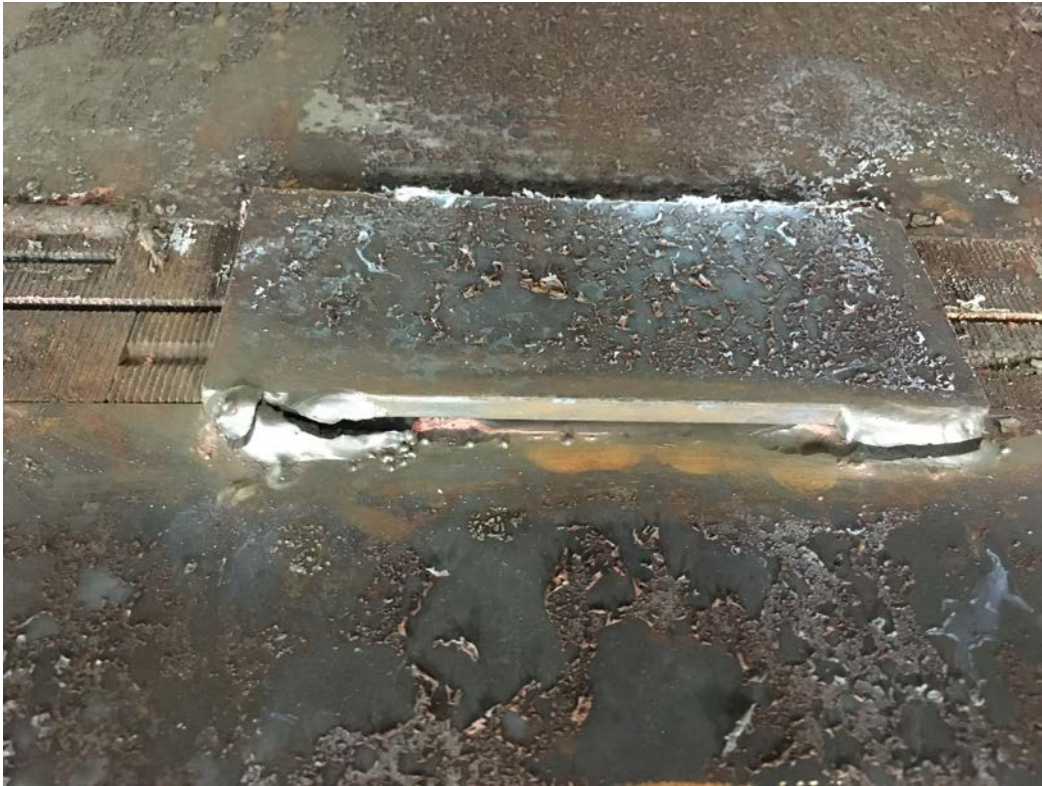
The Working Foreman, Daniel Watkins, of the Fermilab Weld Shops inspected the welds and said that all the failed welds on the tie plates of IQB310 were defective cold welds (lack of fusion). He also pointed out that there were clear marks left when the original tie plates were ground off during a previous rebuild. The Weld Shop Supervisor, James O'Neill, verified Daniel Watkins findings.

Review of historical documentation (see appendix) indicates that only one (IQB310) out of a total of four (4) burned main injector quadrupole magnets has produced flames in the oven. The additional stress from heat may have caused expansion of unknown gasses or prompting the welds to fail.

Figure 2, cracked welds after burning operation

- 1) Check everything on which a lift depends, whether the device is welded or bolted together. Until the magnet and welds can be properly inspected, all lifts shall be fully supported from the bottom surfaces with straps. Once all welds or bolting have been inspected, the designated lifting fixtures utilizing lugs and or other features may be used.
- 2) When burning magnets, the ovens should be properly equipped with instrumentation to trip off in the event of an abnormal behavior such as a pressure spike due to flames or other.
- 3) Verify no traces of coolant or liquids left in circuits. Possibly include a ramp up cycle to remove any remaining moisture prior to reaching final "burn" temperature.

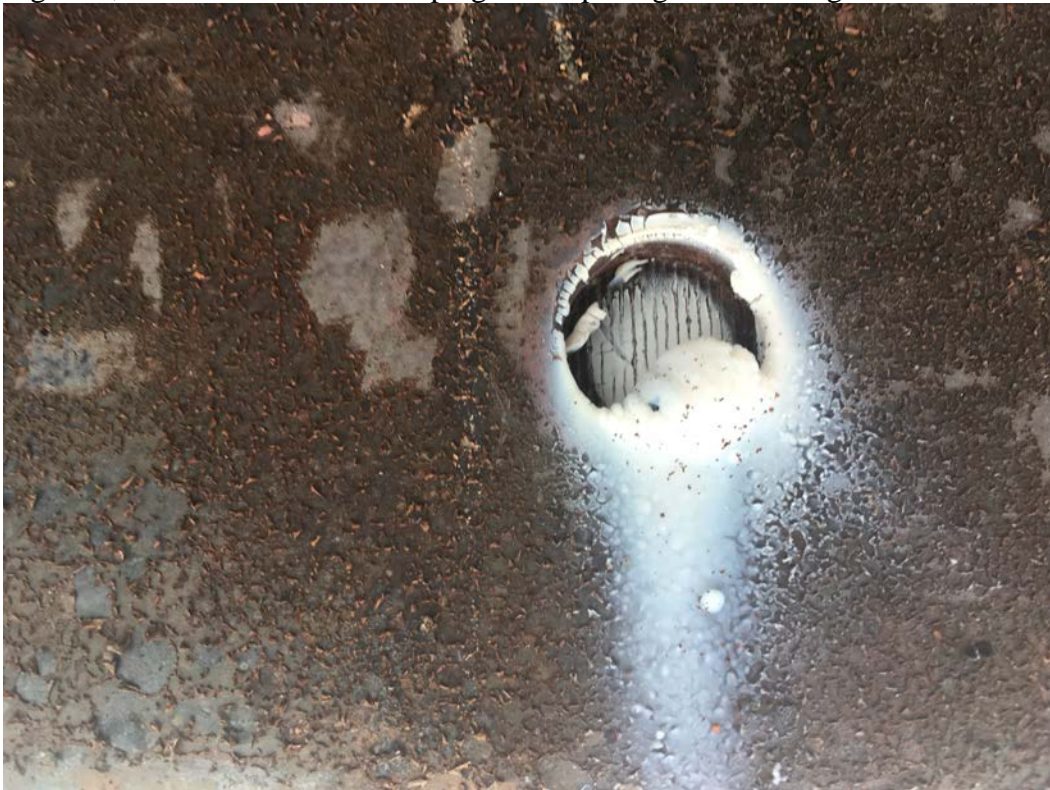
There was also a seepage of an unknown white residue evident near openings, seams and tie plates of IQB310, which is an indication that there was possible contamination of the base metal and welding process.

Figure 3, white residue found seeping from opening after burning
