## NM4 S/CI Shackle Investigation

### Summary

On May 29<sup>th</sup>, 2018 a suspicious-looking 3/4" shackle was found at NM4. The part was removed and set aside for investigation. This document contains a list of observations.

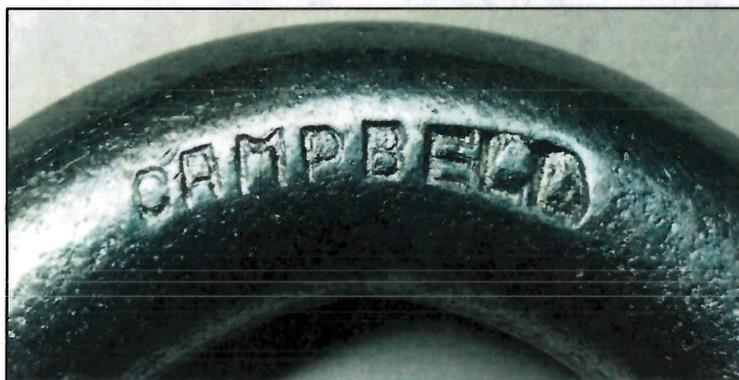
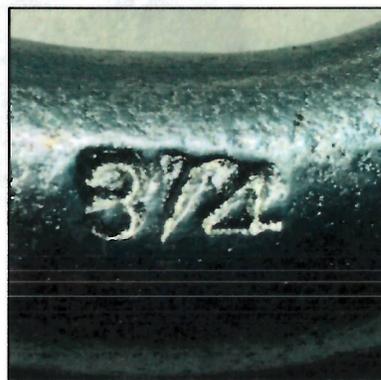
1. Stamping – The depth and size of the stamped characters on this shackle is inconsistent. Additionally, the overall quality and legibility is poor. The lettering, style and orientation of shackles in Campbell's catalogue is vastly different.

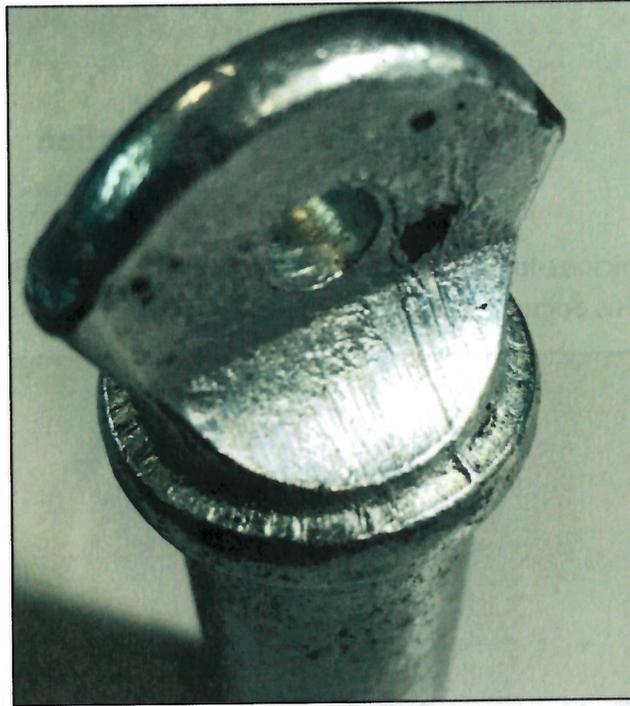
2. Surface Coating – The surface finish on the part is a metallic plating (probably zinc). Campbell's catalogue only lists shackles that are painted or galvanized.

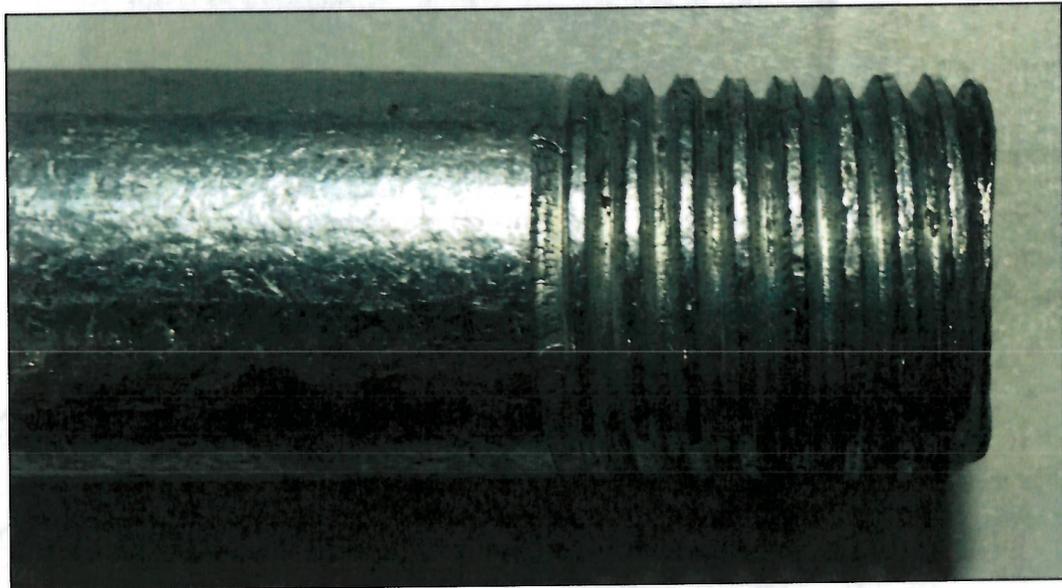
3. Pin Threads – The thread profile used on this shackle and pin does not conform to the ANSI/ASME B1.1 - UNC thread dimensions.

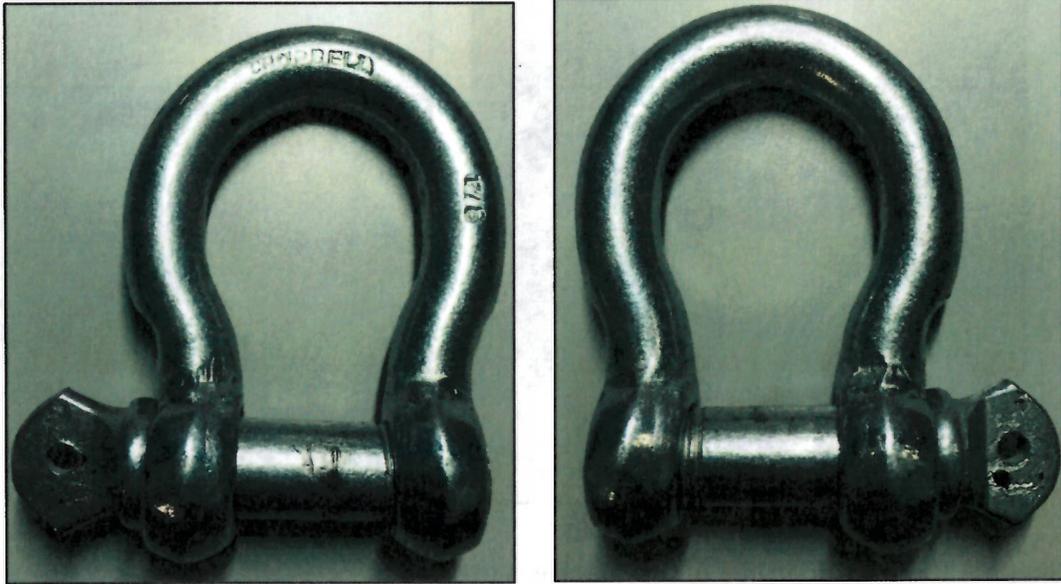
4. No Capacity Rating – In order to conform to ASME B30.26 - Rigging Hardware, new shackles are must have a load capacity forged, cast or die stamped to the shackle body. Campbell's catalogue states that their products have load ratings. The part found in NM4 does not.

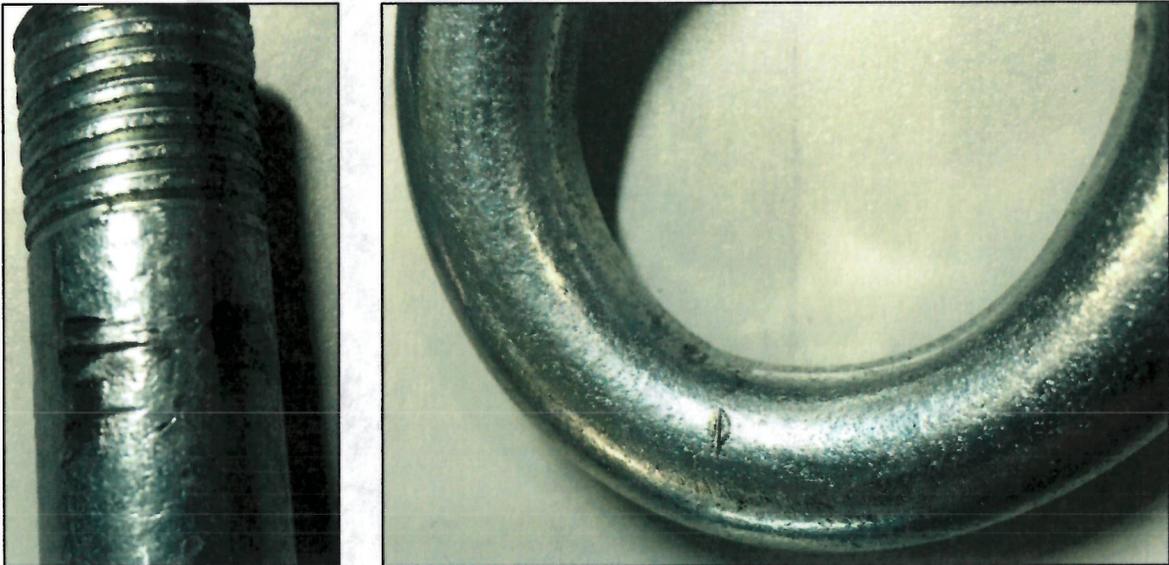
5. Denting – The pin and shackle body both have large indentations. This is not typical behavior for hardened steel and is considered *Removal Criteria* by ASME B30.26.

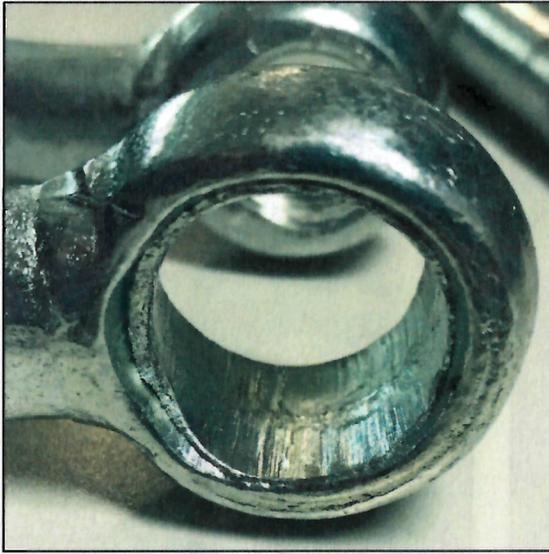
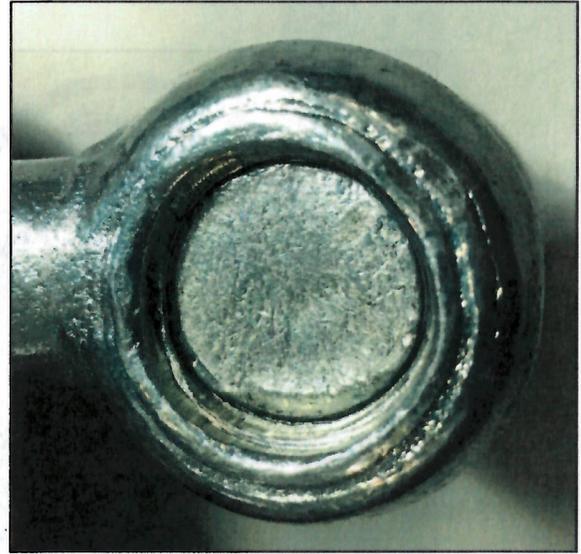
6. Defects – The pin through hole and internal threads show evidence of loose tolerances, voids/porosity and poor manufacturing control.

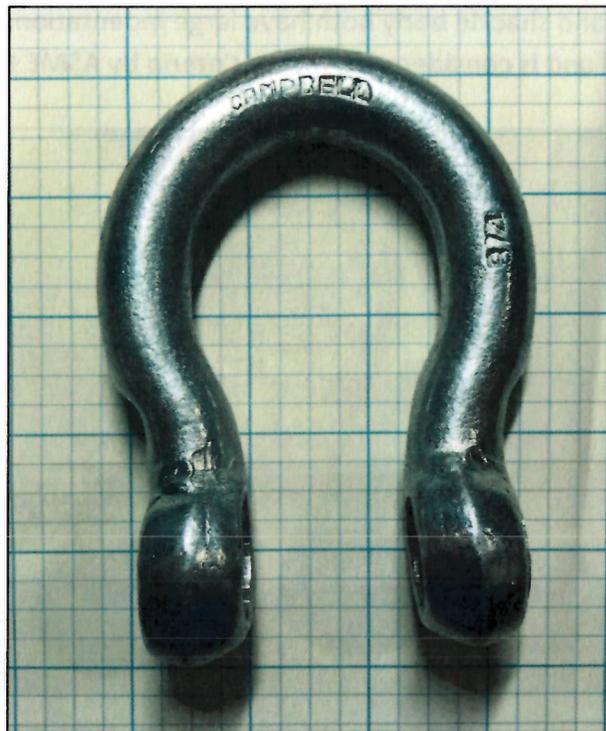
7. Shape – The overall profile of the shackle is irregular.
