71-175-2018

October 23, 2018

Laborer Severely Injured in 60-Foot Fall from Scissor Lift

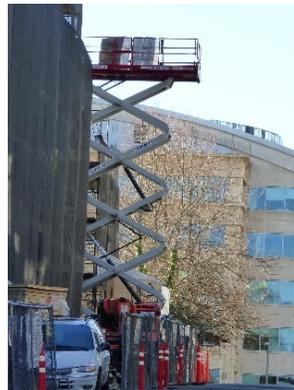
Incident scene showing the scissor lift from which the laborer fell 60 feet.

The day before the incident, an employee reported to a foreman that the rental scissor lift had a broken deck extension locking pin. This spring-loaded pin was used to lock the lift's deck extension in place to keep it from moving while in use. The foreman instructed the lift operator to contact the rental company for a replacement pin and continue to use the lift until a new pin arrived.

On the day of the incident, the replacement pin had not arrived. The victim and another laborer removed a portion of the lift's platform railing so that they could unload insulation bundles from the lift onto the building's sixth floor. They extended the platform to allow access to the floor. The other laborer positioned himself toward the rear of the platform. As he was using his foot to brace the extension to keep it from moving, he passed a bundle toward the victim who was standing on the extension. The victim received the bundle from the laborer and began rolling it along the platform. As he was doing this, the extension rolled back into the retracted position, causing him to lose his balance and fall through the gap between the building and the lift. He landed 60 feet below. He suffered numerous severe injuries. After more than eight months off work he was ready to return to light duty work.

- Do not use damaged or malfunctioning equipment or machinery. Tag and remove from service until it has been repaired by a qualified technician.
- Consider alternative means or equipment to deliver materials to elevation, such as a material hoist or reach forklift.
- Equipment rental companies should have equipment inspected frequently and make all necessary repairs before use. They should also establish a preventative maintenance program based on manufacturer's recommendations, frequency of use, and demands placed on equipment.
- If scissor lift guardrails are removed, employees are required to be protected by the appropriate means of fall protection, such as a personal fall arrest system or fall restraint system.

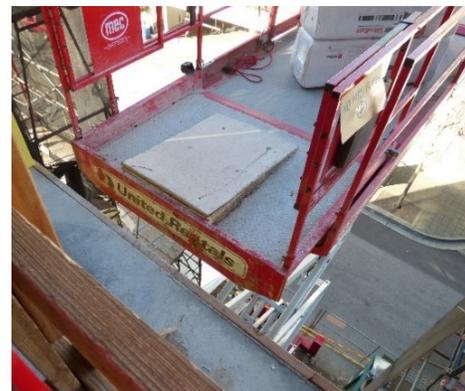
A 39-year-old construction laborer was severely injured when he fell 60 feet to the ground below. He fell through a gap between the scissor lift he was working from and the building when the deck extension platform of the scissor lift moved.

Incident scissor lift showing the gap between the lift platform and the building through which the laborer fell 60 feet.
