## Hanford Operating Experience Program

WRPS-IB-20-009

Lessons Learned

### *Sample Collection Errors Resulted in Over-Quantification of Potential Worker Exposure to Beryllium*

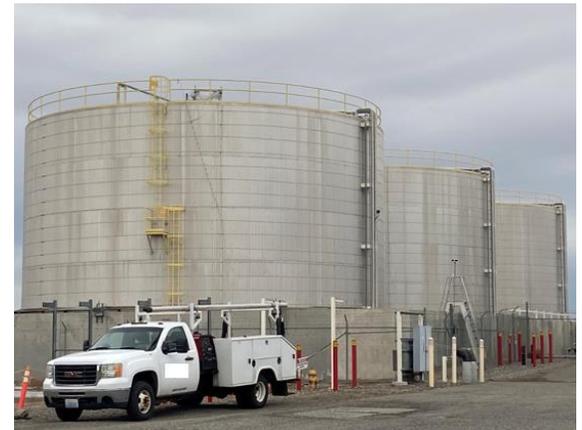
Additional analysis of the personal air sampling results revealed several issues with the sampling techniques employed. A literature review identified that the sampling techniques used for metals analysis during the ETF abrasive blasting project accumulated inertia driven blasting material in the sample cassettes, which is not indicative of potential worker exposure. This inertia driven blasting material collection results in over-

quantification of potential worker exposure. This over-quantification was exacerbated by sample pumps being set to run for two hours, but not being removed from the worker at the time the pump shut off.
