**FIGURE 1:**  
Dorm 4 pre-excavation.

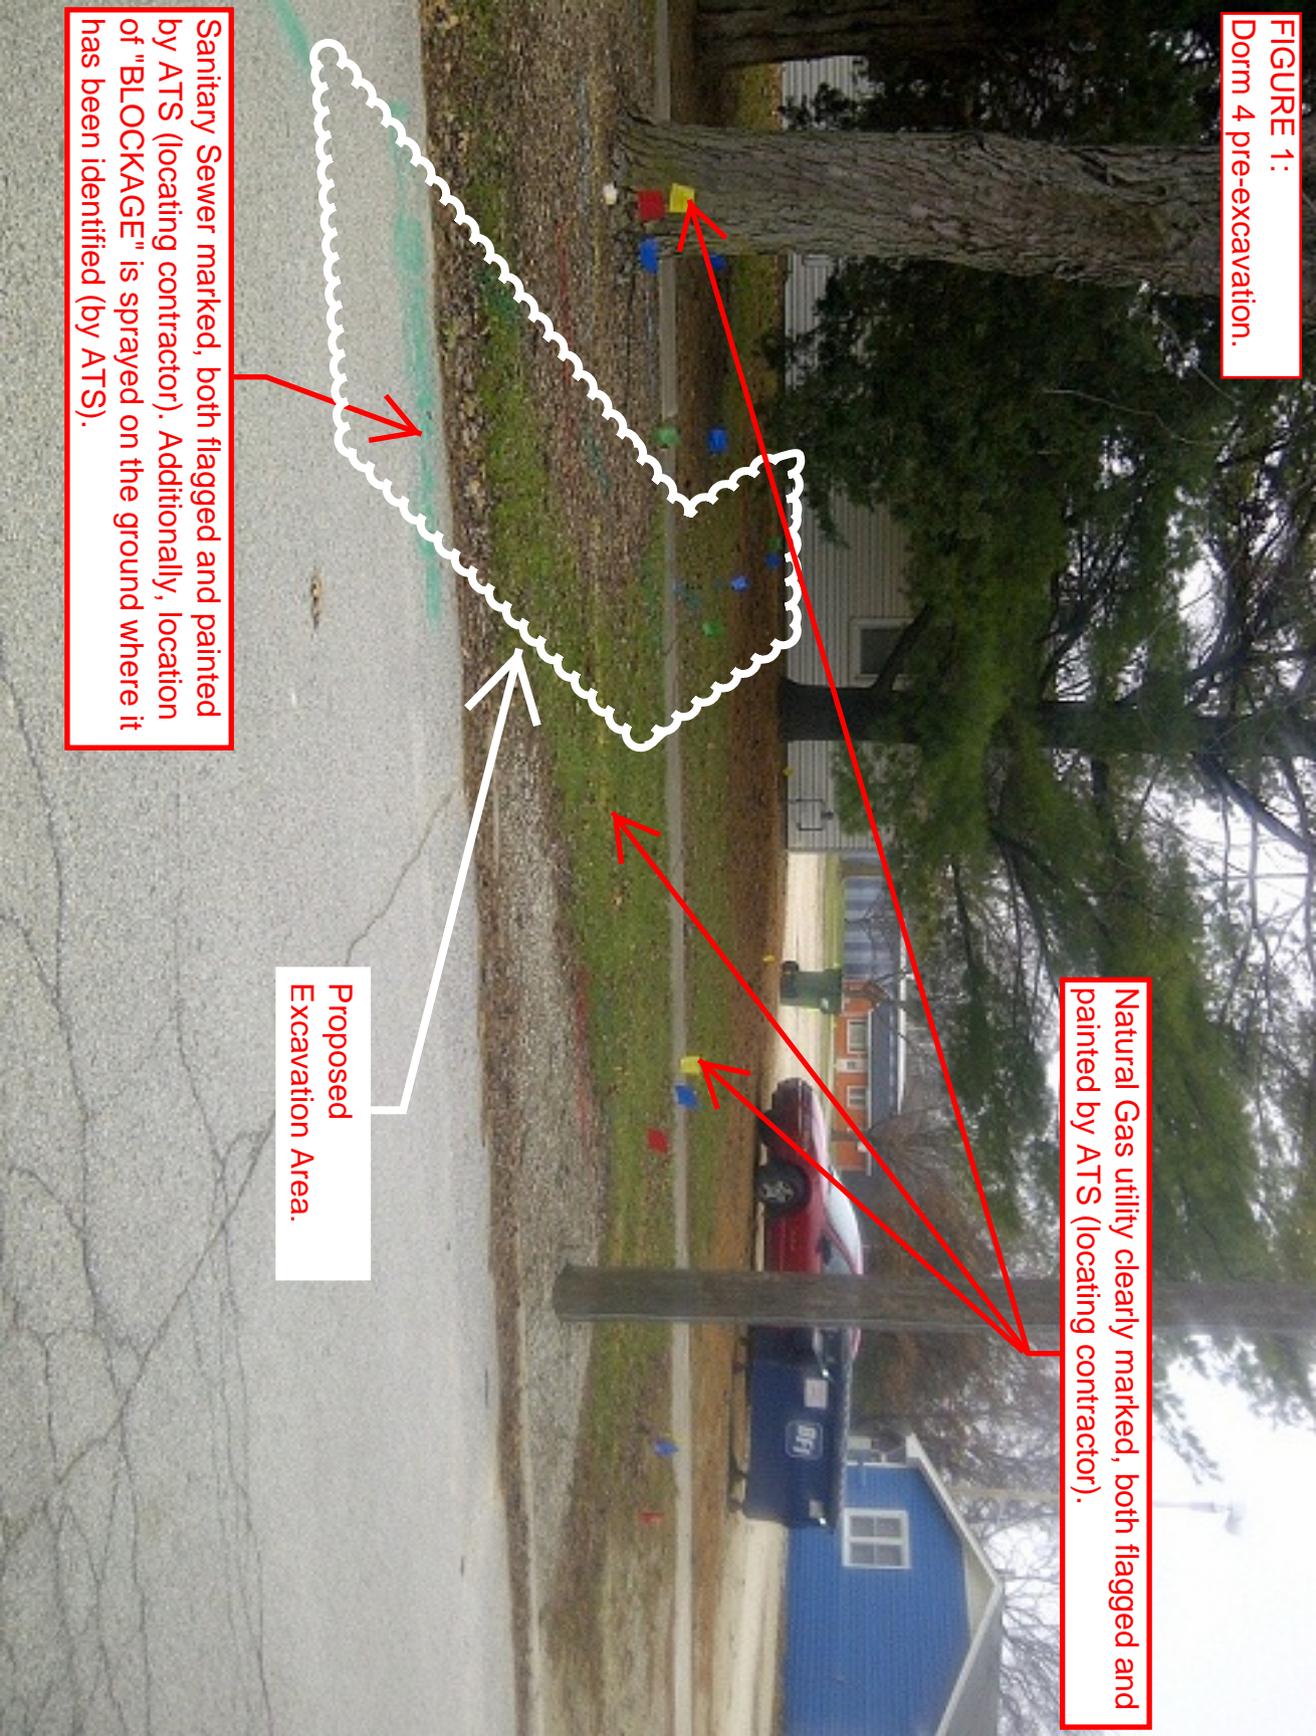
Natural Gas utility clearly marked, both flagged and painted by ATS (locating contractor).

Sanitary Sewer marked, both flagged and painted by ATS (locating contractor). Additionally, location of "BLOCKAGE" is sprayed on the ground where it has been identified (by ATS).

Proposed  
Excavation Area.
