Type B Accident Investigation Board Report on the October 22, 1997, Electrical Arc Blast at Building F-Zero Fermi National Accelerator Laboratory Batavia, Illinois

November 1997

Chicago Operations Office
U.S. Department of Energy

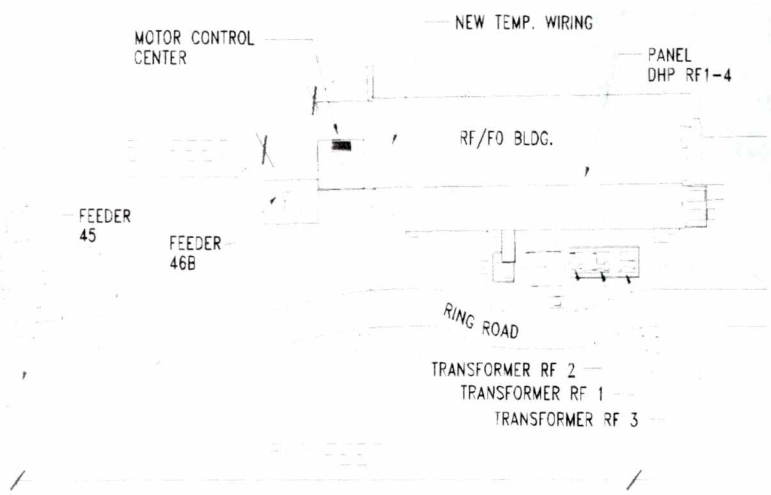
Figure 2-1. Layout of F-Zero Building and Electrical Systems

On October 22, 1997, at 10:00 a.m. Electricians A and B arrived at the RF Room of Building F-Zero to connect four cables in DHP-RF1-4. They completed hooking up the cables at DHP-RF1-4 (see Figure 2-1) shortly before 12:00 noon. At

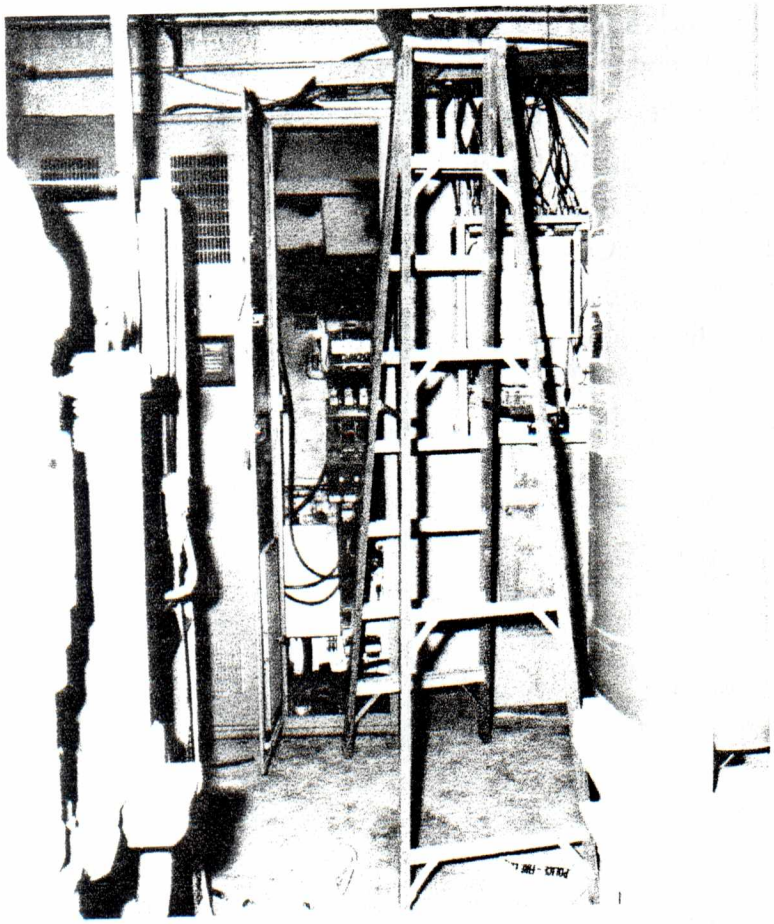
Exhibit 2-1. View of Accident Location

The two electricians set up temporary lighting fed from a portable generator located outside the building. Electrician A placed a step ladder in front of MCC Cabinet #4 as depicted in Exhibit 2-1. He was standing on the second step while Electrician B was standing on the floor next to the ladder and adjacent to MCC Cabinet #4. (See Figure 2-2).

case while Electrician B helped him (see Figure 2-2). During this maneuvering the cover contacted the "C" phase of the bus bar causing a short to ground and a subsequent arc blast.

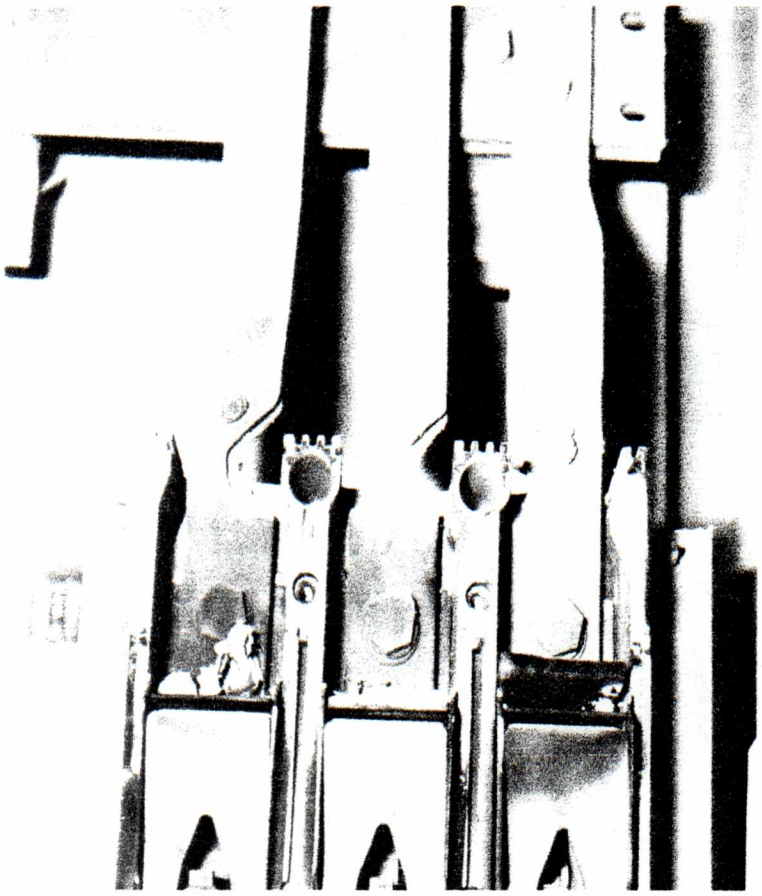
Exhibit 2-2. View of Bus Bar after Electrical Blast

The resulting arc blast vaporized the copper connection (see Exhibit 2-2) and, being deflected by the bus bar cover, was directed downward toward the head and face of Electrician B (see Exhibit 2-3). Electrician B received 2nd and 3rd degree burns to his face and hands while Electrician A, being on the ladder and partially protected by the bus bar cover, received 2nd degree burns to both hands. With the exception of a hard hat (see Exhibit 2-4), no other personal protective equipment was worn by either electrician. Electrician A was knocked off the ladder and both Electrician A and B were temporarily blinded by the arc blast. Electrician B's coat was smoldering when Electrician A's sight returned from the bright arc blast.

The **direct cause** of the accident was the contact of the bus bar cover to phase "C" of MCC Cabinet #4. However, there are also root causes and contributing causes. **Root causes** are the fundamental causes that, if corrected would prevent recurrence of this and similar accidents. **Contributing causes** are other causes that, would not, by themselves, have prevented the accident but are important enough to be recognized as needing corrective action. An Events and Causal Factors Analysis was used to evaluate the causal factors of this accident. A summary of this analysis is contained in Table 2-2.

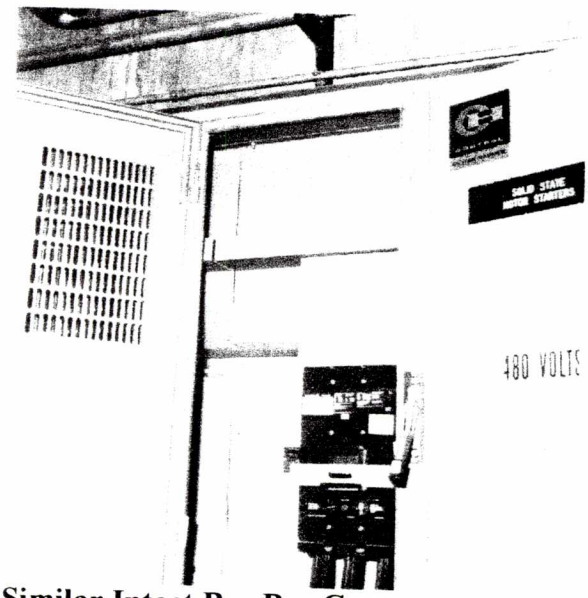
Exhibit 2-3. Comparison of an Intact and the Damaged + Bus Bar Cover

The Damaged Bus Bar Cover

Similar Intact Bus Bar Cover

Injured Parties	Electricians A and B
Phys. Barrier	**MCC Cabinet #4 Bus Bar Cover** The physical barrier between the Electricians and the 480 VAC energy source in MCC Cabinet #4 enclosure was the bus bar cover. Electricians A and B attempted to remove the bus bar cover to locate a connection for the neutral conductor. This barrier failed because the metal bus bar cover contacted the "C" phase of the 480 VAC service.
Admin. Barriers	**Hazards Analysis** The hazards identification for the Electricians was not adequate, was not documented, and was not sufficiently comprehensive to identify hazards and appropriate controls associated with work in MCC Cabinet #4, thereby causing this barrier to fail.
	Electrical Engineering Drawings The Electricians did not request nor were they furnished electrical engineering drawings for the system. These drawings could have correctly identified the difference in configuration of electrical systems fed by Feeder 46B in the F-Zero Compressor Room and Feeder 45 in the F-Zero RF Room.

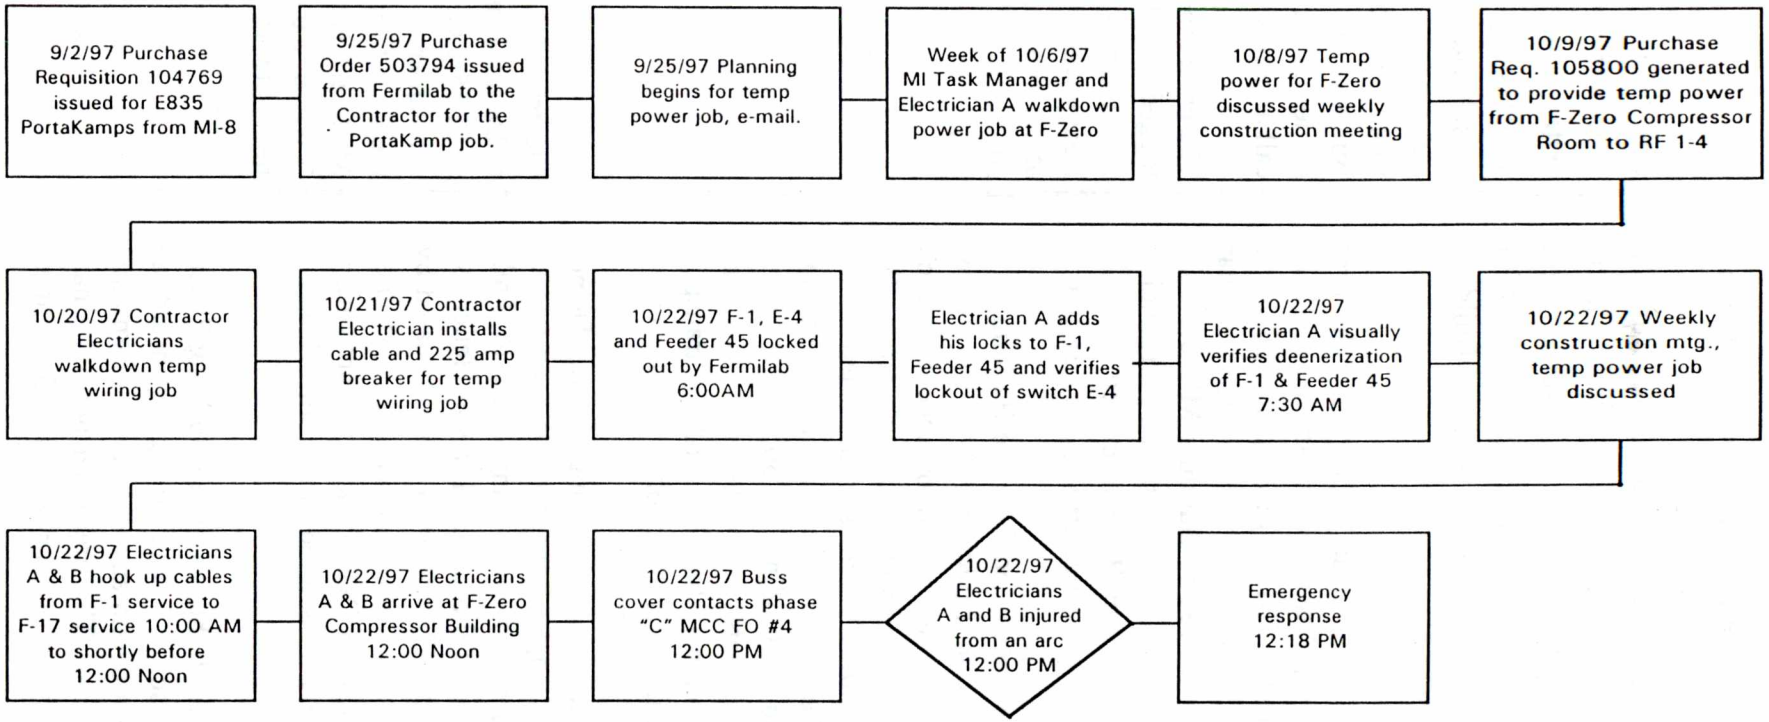
Figure 2-3 Summary Events and Accident Chronology

Figure 2-3 summarizes the chronology of significant events.

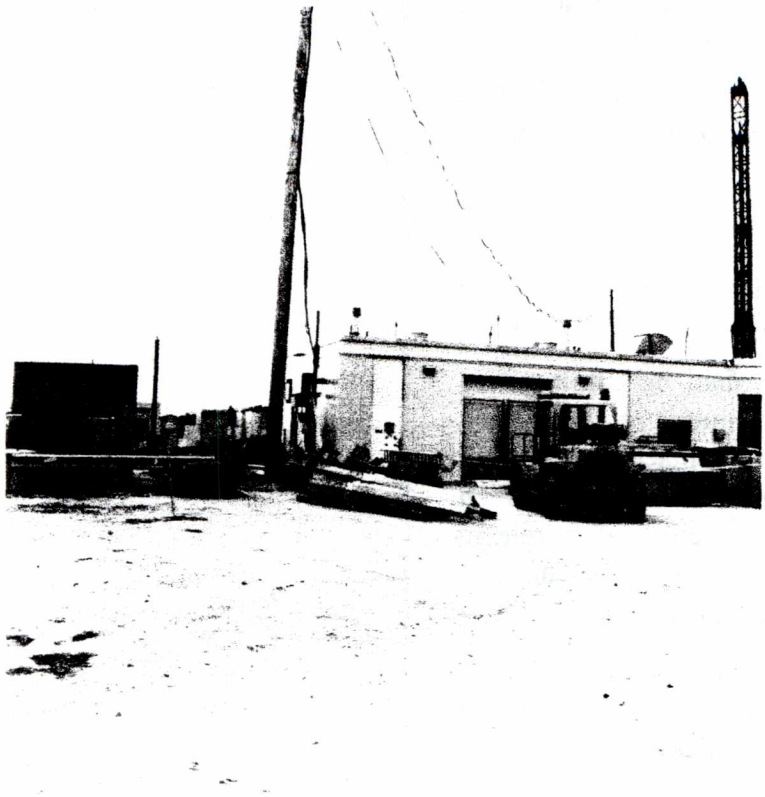
Exhibit 2-6. Feeder 46B and Building F-Zero Compressor Room

On October 21, 1997, two Contractor electricians pulled four cables from the F-Zero Compressor Room to the F-Zero RF Room. This involved installing a 225 A circuit breaker in MCC Cabinet #4. The three load phases were installed in the motor control center, with the neutral remaining to be installed the next day. It took approximately eight hours to complete this part of the job. The Electricians believed that Building F-Zero was deenergized and, hence, they did not use lockout/tagout or voltage verification to install the new 225 A breaker, as required by 29 CFR 1910.333(b)(2),
