ENGINEERING REPORT

2012 THERMOGRAPHIC SURVEY AND EQUIPMENT INSPECTION

HIGH VOLTAGE MAINTENANCE

April 19, 2012

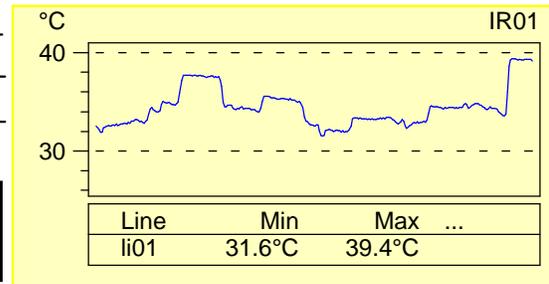
Exhibits a temperature rise of 4.80°C above normal.

Label	Value	Diff	Formula
SP01*	38.0°C		
SP02	33.2°C	DI01: 4.80°C	SP01 - SP02

PROBABLE CAUSE:	RECOMMENDED ACTION:	ACTION REQUIRED:												
Loose Component/Connection	Secure Power	Possible deficiency; warrants investigation												
Oxidation of Connection(s)	Clean and tighten connections	X Probable deficiency; repair at next outage												
Overloaded Circuit(s)	X Determine cause of unbalance	Major deficiency; immediate action required.												
X Unbalanced Circuit(s)	X Distribute the load more evenly	None - Corrected at the time of scan												
Bad or Failing Fuse(s)	Determine the cause of overload	X Repair and Verify with Infrared Scan												
Bad or Failing Circuit Breaker(s)	Reduce load to below 80% of FLA	REPAIR PRIORITY RATING: 3												
Code Violation	Replace Conductor(s)													
(See Engineering Report for Code Violation Description and Details)	Replace Fuse(s)													
	Replace Circuit Breaker(s)													
	Replace Bus

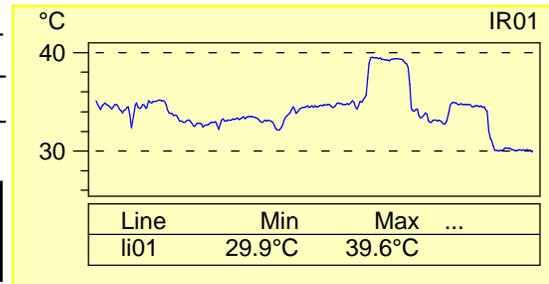
Exhibits a temperature rise of 5.49°C above normal.

Label	Value	Diff	Formula
SP01*	39.6°C		
SP02	34.1°C	DI01: 5.49°C	SP01 - SP02

PROBABLE CAUSE:	RECOMMENDED ACTION:	ACTION REQUIRED:												
Loose Component/Connection	Secure Power	Possible deficiency; warrants investigation												
Oxidation of Connection(s)	Clean and tighten connections	X Probable deficiency; repair at next outage												
Overloaded Circuit(s)	X Determine cause of unbalance	Major deficiency; immediate action required.												
X Unbalanced Circuit(s)	X Distribute the load more evenly	None - Corrected at the time of scan												
Bad or Failing Fuse(s)	Determine the cause of overload	X Repair and Verify with Infrared Scan												
Bad or Failing Circuit Breaker(s)	Reduce load to below 80% of FLA	REPAIR PRIORITY RATING: 3												
Code Violation	Replace Conductor(s)													
(See Engineering Report for Code Violation Description and Details)	Replace Fuse(s)													
	Replace Circuit Breaker(s)													
	Replace Bus

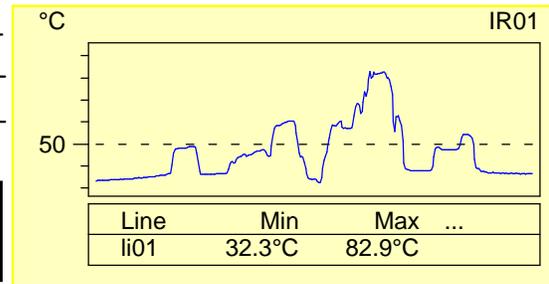
IMAGE # 0649

Exhibits a temperature rise of 36.38°C above normal.

Label	Value	Diff	Formula
SP01*	84.5°C		
SP02	48.1°C	DI01: 36.38°C	SP01 - SP02
SP03	76.3°C		
SP04	49.6°C

PROBABLE CAUSE:		RECOMMENDED ACTION:	ACTION REQUIRED:		
<input checked="" type="checkbox"/>	Loose Component/Connection	Secure Power	Possible deficiency; warrants investigation		
	Oxidation of Connection(s)	<input checked="" type="checkbox"/> Clean and tighten connections	Probable deficiency; repair at next outage		
	Overloaded Circuit(s)	Determine cause of unbalance	<input checked="" type="checkbox"/> Major deficiency; immediate action required.		
	Unbalanced Circuit(s)	Distribute the load more evenly	None - Corrected at the time of scan		
	Bad or Failing Fuse(s)	Determine the cause of overload	<input checked="" type="checkbox"/> Repair and Verify with Infrared Scan		
	Bad or Failing Circuit Breaker(s)	Reduce load to below 80% of FLA	REPAIR PRIORITY RATING: 1		
	Code Violation	Replace Conductor(s)	Ø	Ø AMPS	% FLA
	(See Engineering Report for Code Violation Description and Details)	Replace Fuse(s)	A	35.5

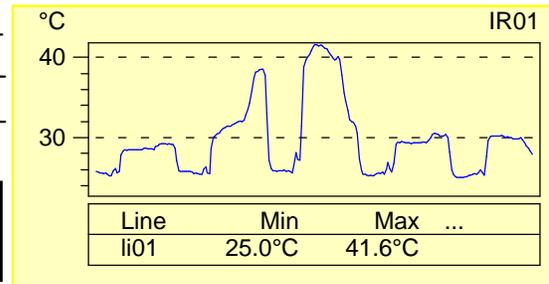
IMAGE # 0635

- 1.0 **Building FCC; Floor 2; Computer Room; UPS-PP-11; Breakers 27 and 29** – These breakers are exhibiting elevated temperature when compared to the ambient temperature. The breakers may have a loose connection or may be bad/failing. We recommend investigation. (See Page 70)

Exhibits a temperature rise of 12.65°C above normal.

Label	Value	Diff	Formula
SP01*	42.0°C		
SP02	29.3°C	DI01: 12.65°C	SP01 - SP02

PROBABLE CAUSE:	RECOMMENDED ACTION:	ACTION REQUIRED:
Loose Component/Connection	Secure Power	Possible deficiency; warrants investigation
Oxidation of Connection(s)	Clean and tighten connections	Probable deficiency; repair at next outage
Overloaded Circuit(s)	Determine cause of unbalance	X Major deficiency; immediate action required.
Unbalanced Circuit(s)	Distribute the load more evenly	None - Reference Only
Bad or Failing Fuse(s)	Determine the cause of overload	X Repair and Verify with Infrared Scan
Bad or Failing Circuit Breaker(s)	Reduce load to below 80% of FLA	REPAIR PRIORITY RATING: 2
Code Violation	Replace Conductor(s)	
(See Engineering Report for Code Violation Description and Details)	Replace Fuse(s)	Ø
	Replace Circuit Breaker(s)	Ø AMPS
X Reference Only	Replace Bus	% FLA
	X No Action is Required	Breaker 27
		21
		70%
		Breaker 29
		21
		70%

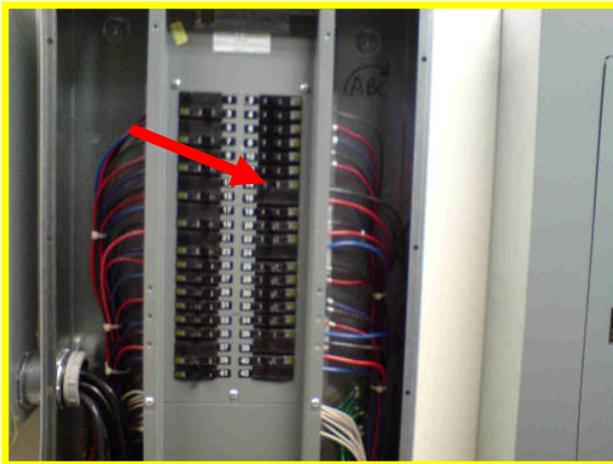
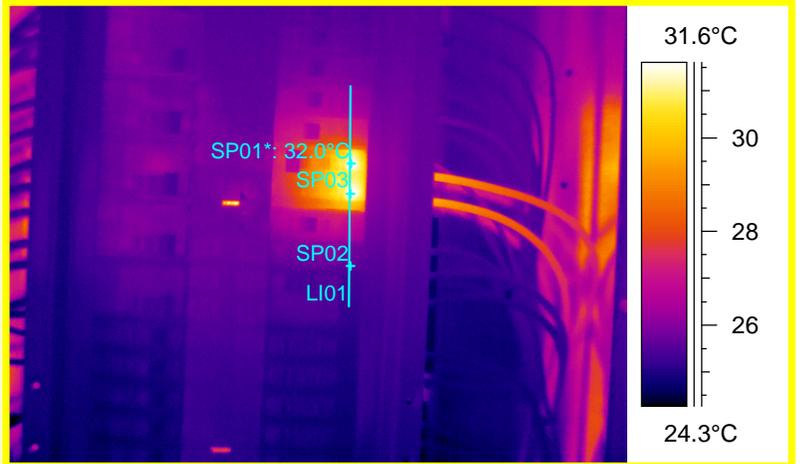
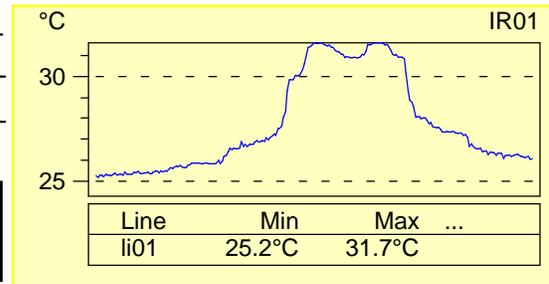
PHOTO # 0641

Exhibits a temperature rise of 6.42°C above normal.

Label	Value	Diff	Formula
SP01*	32.0°C		
SP02	25.6°C	DI01: 6.42°C	SP01 - SP02
SP03	31.6°C

PROBABLE CAUSE:	RECOMMENDED ACTION:	ACTION REQUIRED:		
Loose Component/Connection	Secure Power	Possible deficiency; warrants investigation		
Oxidation of Connection(s)	Clean and tighten connections	Probable deficiency; repair at next outage		
Overloaded Circuit(s)	Determine cause of unbalance	Major deficiency; immediate action required.		
Unbalanced Circuit(s)	Distribute the load more evenly	X	None - Reference Only	
Bad or Failing Fuse(s)	Determine the cause of overload	Repair and Verify with Infrared Scan		
Bad or Failing Circuit Breaker(s)	Reduce load to below 80% of FLA	REPAIR PRIORITY RATING: 0		
Code Violation	Replace Conductor(s)	Ø	Ø AMPS	% FLA
(See Engineering Report for Code	Replace Fuse(s)	A	N/A	
Violation Description and Details)	Replace Circuit Breaker(s)	B	N/A	
X Reference Only	Replace Bus	C	N/A	
	X No Action is Required

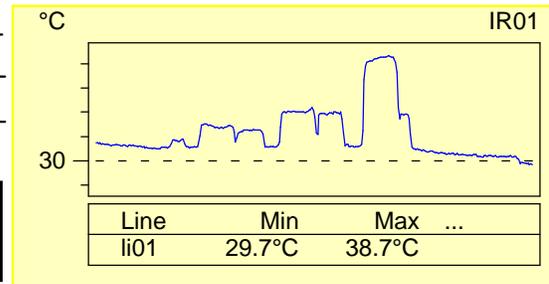
Exhibits a temperature rise of 5.96°C above normal.

Label	Value	Diff	Formula
SP01*	39.0°C		
SP02	33.0°C	DI01: 5.96°C	SP01 - SP02

PROBABLE CAUSE:	RECOMMENDED ACTION:	ACTION REQUIRED:																
Loose Component/Connection	Secure Power	Possible deficiency; warrants investigation																
Oxidation of Connection(s)	Clean and tighten connections	X Probable deficiency; repair at next outage																
Overloaded Circuit(s)	X Determine cause of unbalance	Major deficiency; immediate action required.																
X Unbalanced Circuit(s)	X Distribute the load more evenly	None - Corrected at the time of scan																
Bad or Failing Fuse(s)	Determine the cause of overload	X Repair and Verify with Infrared Scan																
Bad or Failing Circuit Breaker(s)	Reduce load to below 80% of FLA	REPAIR PRIORITY RATING: 3																
Code Violation	Replace Conductor(s)																	
(See Engineering Report for Code Violation Description and Details)	Replace Fuse(s)																	
	Replace Circuit Breaker(s)																	
	Replace Bus

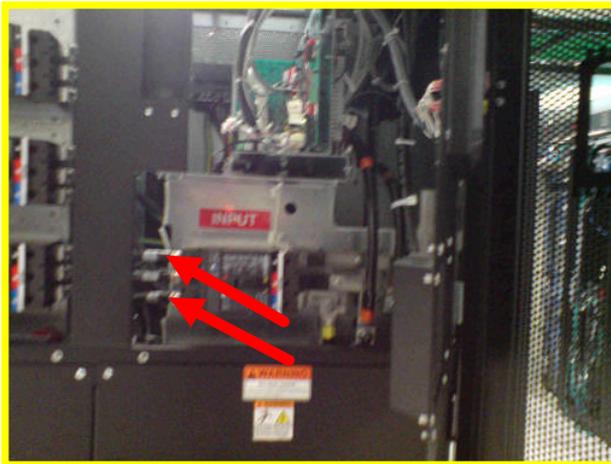
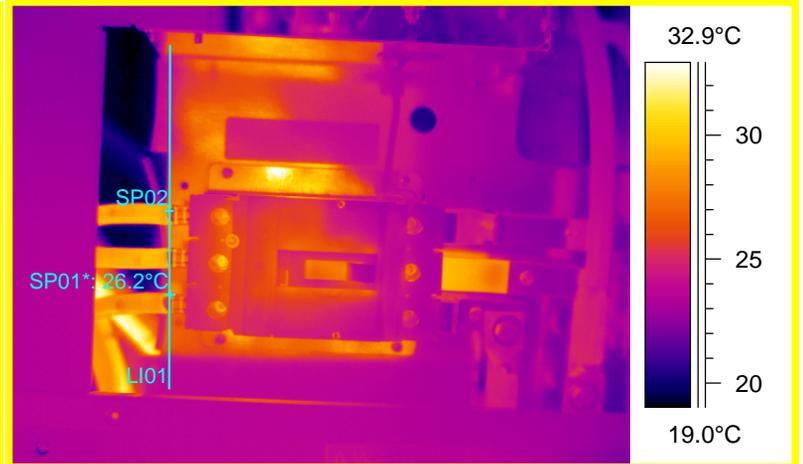
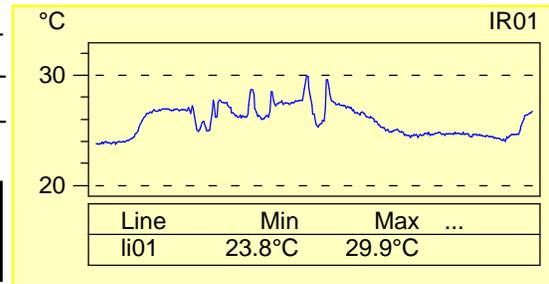
PHOTO # 0647

Exhibits a temperature rise of 0.14°C above normal.

Label	Value	Diff	Formula
SP01*	26.2°C		
SP02	26.1°C	DI01: 0.14°C	SP01 - SP02

PROBABLE CAUSE:	RECOMMENDED ACTION:	ACTION REQUIRED:
Loose Component/Connection	Secure Power	Possible deficiency; warrants investigation
Oxidation of Connection(s)	Clean and tighten connections	Probable deficiency; repair at next outage
Overloaded Circuit(s)	Determine cause of unbalance	Major deficiency; immediate action required.
Unbalanced Circuit(s)	Distribute the load more evenly	X None - Reference Only
Bad or Failing Fuse(s)	Determine the cause of overload	Repair and Verify with Infrared Scan
Bad or Failing Circuit Breaker(s)	Reduce load to below 80% of FLA	REPAIR PRIORITY RATING: 0
Code Violation	Replace Conductor(s)	
(See Engineering Report for Code Violation Description and Details)	Replace Fuse(s)	Ø
	Replace Circuit Breaker(s)	Ø AMPS
X Reference Only	Replace Bus	% FLA
		A
		B
	X No Action Required	C

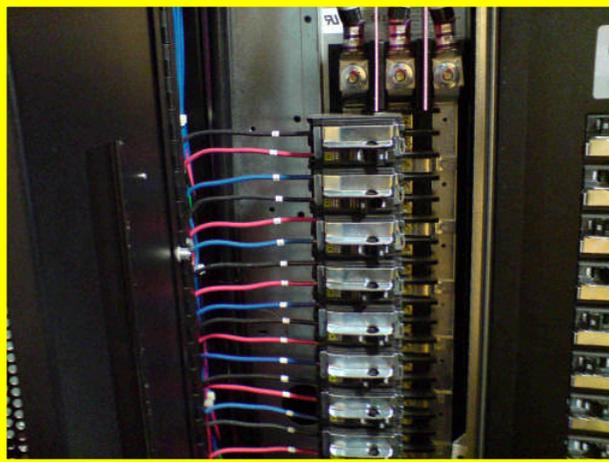
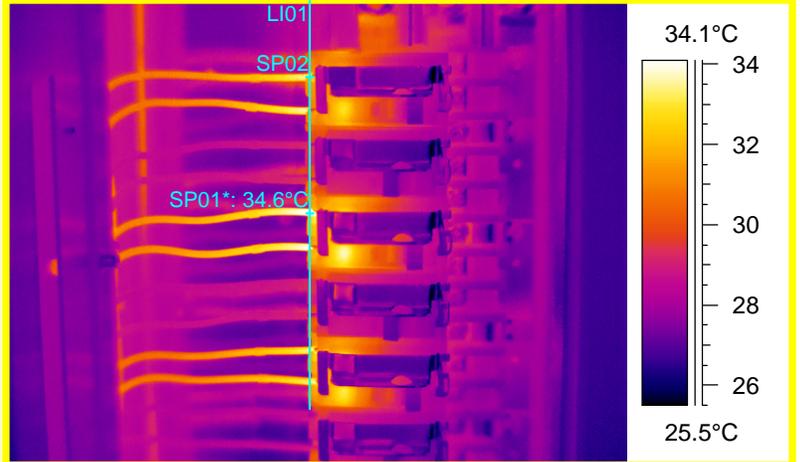
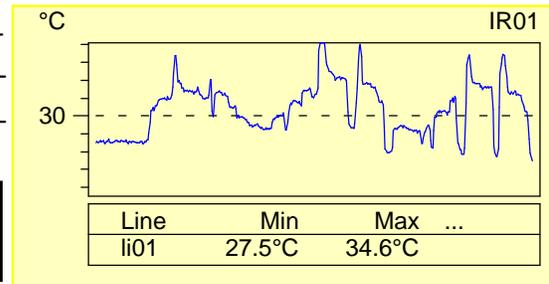
PHOTO # 0631

Exhibits a temperature rise of 1.66°C above normal.

Label	Value	Diff	Formula
SP01*	34.6°C		
SP02	32.9°C	DI01: 1.66°C	SP01 - SP02

PROBABLE CAUSE:	RECOMMENDED ACTION:	ACTION REQUIRED:
Loose Component/Connection	Secure Power	Possible deficiency; warrants investigation
Oxidation of Connection(s)	Clean and tighten connections	Probable deficiency; repair at next outage
Overloaded Circuit(s)	Determine cause of unbalance	Major deficiency; immediate action required.
Unbalanced Circuit(s)	Distribute the load more evenly	X None - Reference Only
Bad or Failing Fuse(s)	Determine the cause of overload	Repair and Verify with Infrared Scan
Bad or Failing Circuit Breaker(s)	Reduce load to below 80% of FLA	REPAIR PRIORITY RATING: 0
Code Violation	Replace Conductor(s)	
(See Engineering Report for Code Violation Description and Details)	Replace Fuse(s)	Ø
	Replace Circuit Breaker(s)	A
	Replace Bus	B
X Reference Only	X No Action Required	C

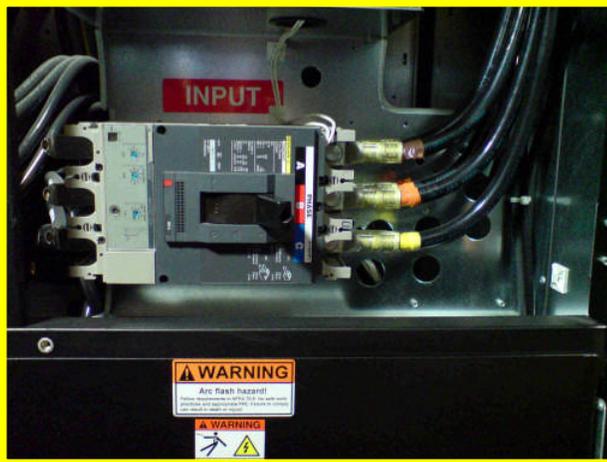
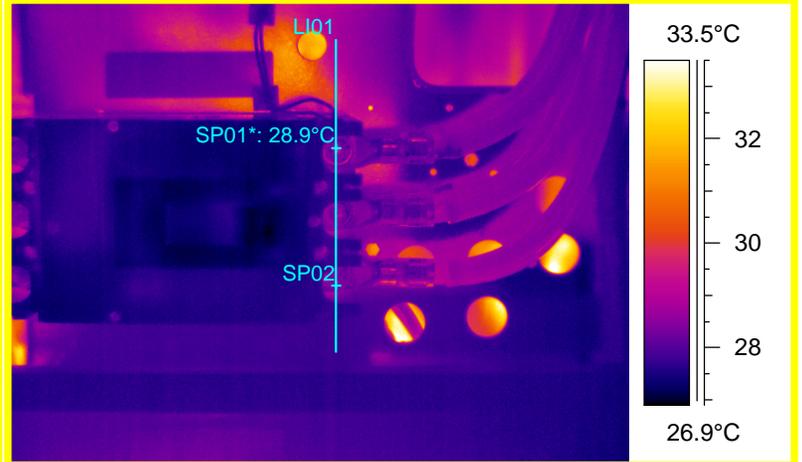
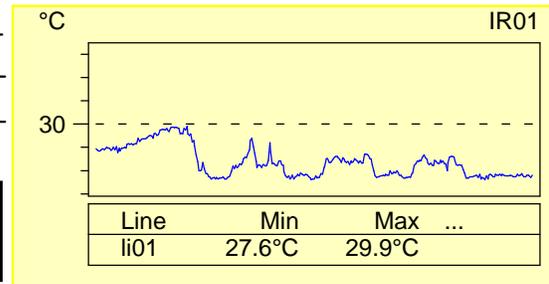
PHOTO # 0633

Exhibits a temperature rise of 0.39°C above normal.

Label	Value	Diff	Formula
SP01*	28.9°C		
SP02	28.5°C	DI01: 0.39°C	SP01 - SP02

PROBABLE CAUSE:	RECOMMENDED ACTION:	ACTION REQUIRED:
Loose Component/Connection	Secure Power	Possible deficiency; warrants investigation
Oxidation of Connection(s)	Clean and tighten connections	Probable deficiency; repair at next outage
Overloaded Circuit(s)	Determine cause of unbalance	Major deficiency; immediate action required.
Unbalanced Circuit(s)	Distribute the load more evenly	X None - Reference Only
Bad or Failing Fuse(s)	Determine the cause of overload	Repair and Verify with Infrared Scan
Bad or Failing Circuit Breaker(s)	Reduce load to below 80% of FLA	REPAIR PRIORITY RATING: 0
Code Violation	Replace Conductor(s)	
(See Engineering Report for Code Violation Description and Details)	Replace Fuse(s)	∅
	Replace Circuit Breaker(s)	A
X Reference Only	Replace Bus	B
	X No Action Required	C

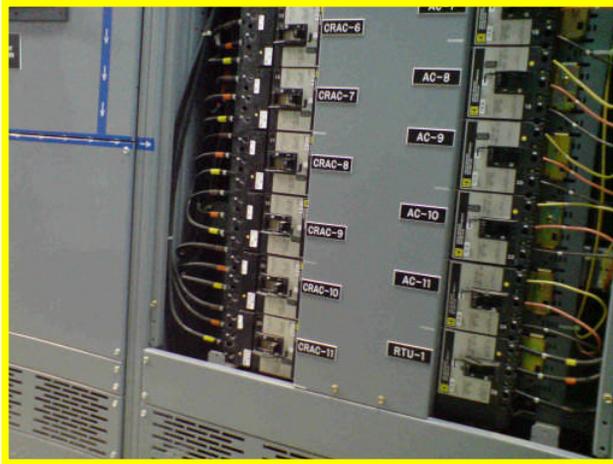
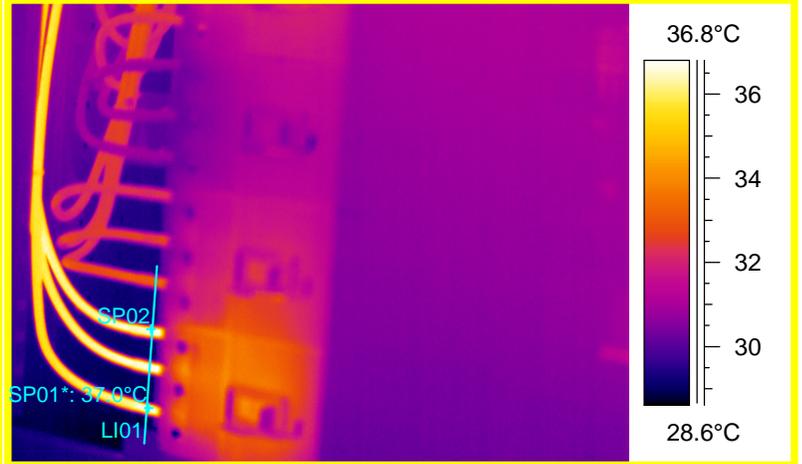
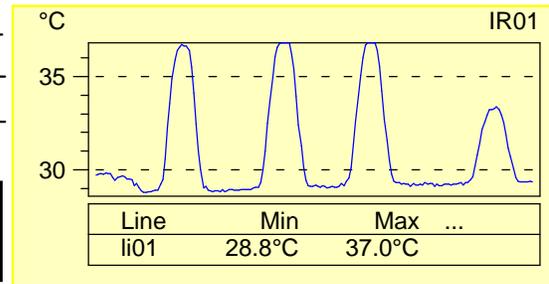
PHOTO # 0613

Exhibits a temperature rise of 0.40°C above normal.

Label	Value	Diff	Formula
SP01*	37.0°C		
SP02	36.6°C	DI01: 0.40°C	SP01 - SP02

PROBABLE CAUSE:	RECOMMENDED ACTION:	ACTION REQUIRED:
Loose Component/Connection	Secure Power	Possible deficiency; warrants investigation
Oxidation of Connection(s)	Clean and tighten connections	Probable deficiency; repair at next outage
Overloaded Circuit(s)	Determine cause of unbalance	Major deficiency; immediate action required.
Unbalanced Circuit(s)	Distribute the load more evenly	X None - Reference Only
Bad or Failing Fuse(s)	Determine the cause of overload	Repair and Verify with Infrared Scan
Bad or Failing Circuit Breaker(s)	Reduce load to below 80% of FLA	REPAIR PRIORITY RATING: 0
Code Violation	Replace Conductor(s)	
(See Engineering Report for Code Violation Description and Details)	Replace Fuse(s)	Ø
	Replace Circuit Breaker(s)	Ø AMPS
X Reference Only	Replace Bus	% FLA
	X No Action Required	A
		B
		C

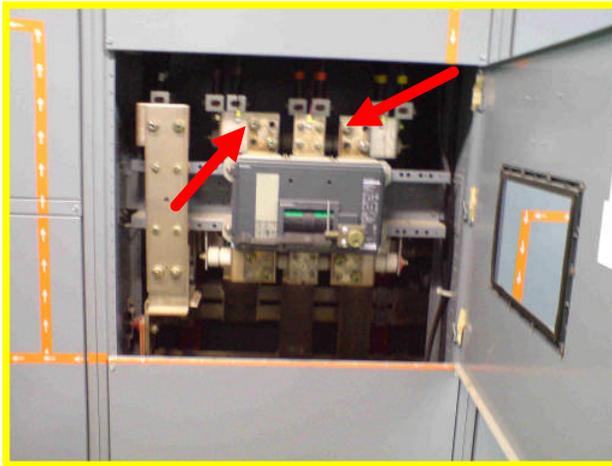
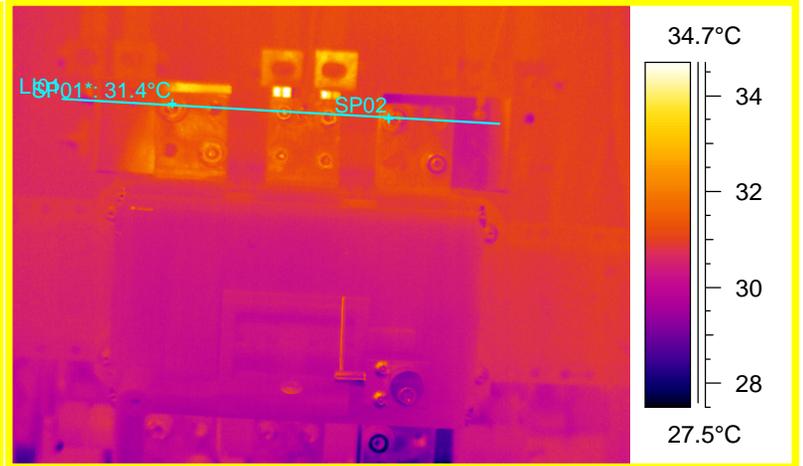
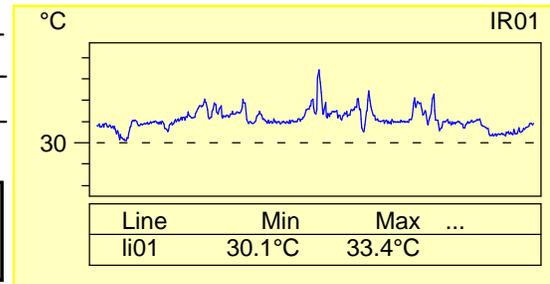
PHOTO # 0617

Exhibits a temperature rise of 0.19°C above normal.

Label	Value	Diff	Formula
SP01*	31.4°C		
SP02	31.2°C	DI01: 0.19°C	SP01 - SP02

PROBABLE CAUSE:	RECOMMENDED ACTION:	ACTION REQUIRED:
Loose Component/Connection	Secure Power	Possible deficiency; warrants investigation
Oxidation of Connection(s)	Clean and tighten connections	Probable deficiency; repair at next outage
Overloaded Circuit(s)	Determine cause of unbalance	Major deficiency; immediate action required.
Unbalanced Circuit(s)	Distribute the load more evenly	X None - Reference Only
Bad or Failing Fuse(s)	Determine the cause of overload	Repair and Verify with Infrared Scan
Bad or Failing Circuit Breaker(s)	Reduce load to below 80% of FLA	REPAIR PRIORITY RATING: 0
Code Violation	Replace Conductor(s)	
(See Engineering Report for Code Violation Description and Details)	Replace Fuse(s)	Ø
	Replace Circuit Breaker(s)	Ø AMPS
X Reference Only	Replace Bus	% FLA
	X No Action Required	A
		B
		C

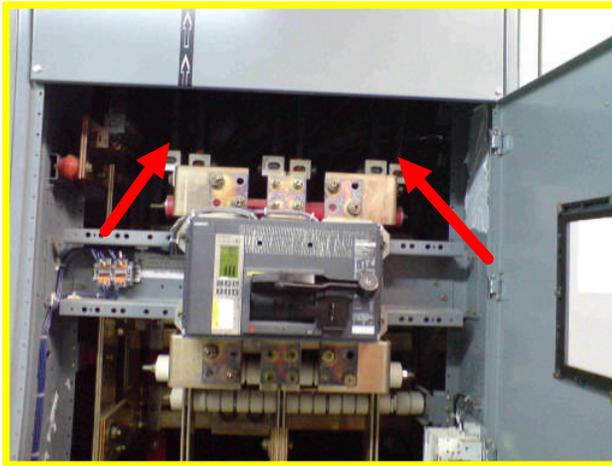
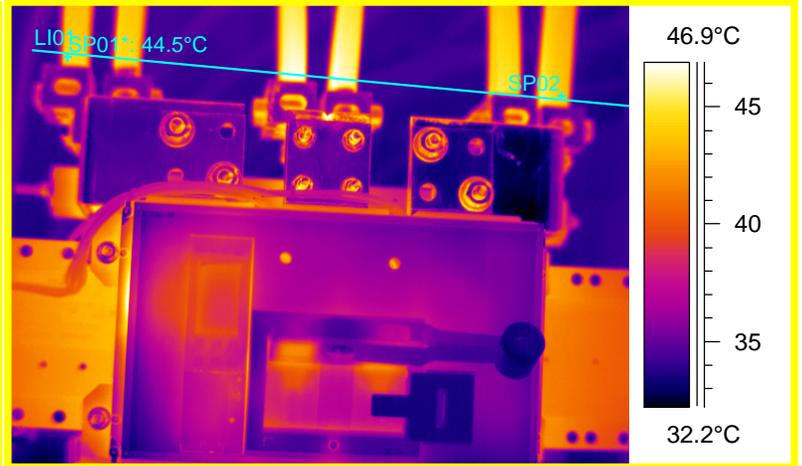
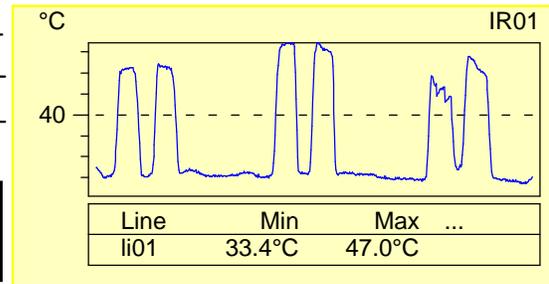
PHOTO # 0619

Exhibits a temperature rise of 0.55°C above normal.

Label	Value	Diff	Formula
SP01*	44.5°C		
SP02	44.0°C	DI01: 0.55°C	SP01 - SP02

PROBABLE CAUSE:	RECOMMENDED ACTION:	ACTION REQUIRED:
Loose Component/Connection	Secure Power	Possible deficiency; warrants investigation
Oxidation of Connection(s)	Clean and tighten connections	Probable deficiency; repair at next outage
Overloaded Circuit(s)	Determine cause of unbalance	Major deficiency; immediate action required.
Unbalanced Circuit(s)	Distribute the load more evenly	X None - Reference Only
Bad or Failing Fuse(s)	Determine the cause of overload	Repair and Verify with Infrared Scan
Bad or Failing Circuit Breaker(s)	Reduce load to below 80% of FLA	REPAIR PRIORITY RATING: 0
Code Violation	Replace Conductor(s)	
(See Engineering Report for Code Violation Description and Details)	Replace Fuse(s)	Ø
	Replace Circuit Breaker(s)	Ø AMPS
X Reference Only	Replace Bus	% FLA
		A
		B
	X No Action Required	C

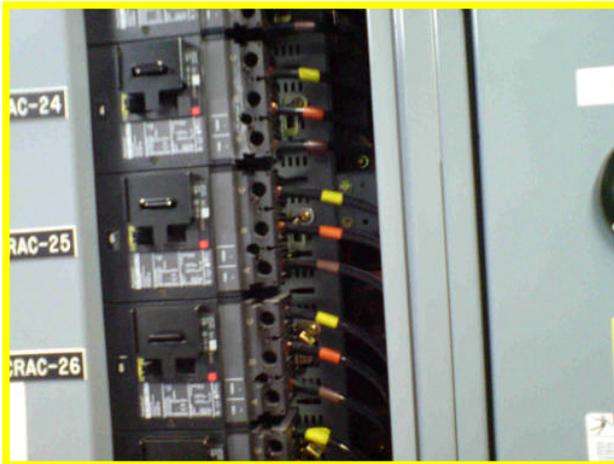
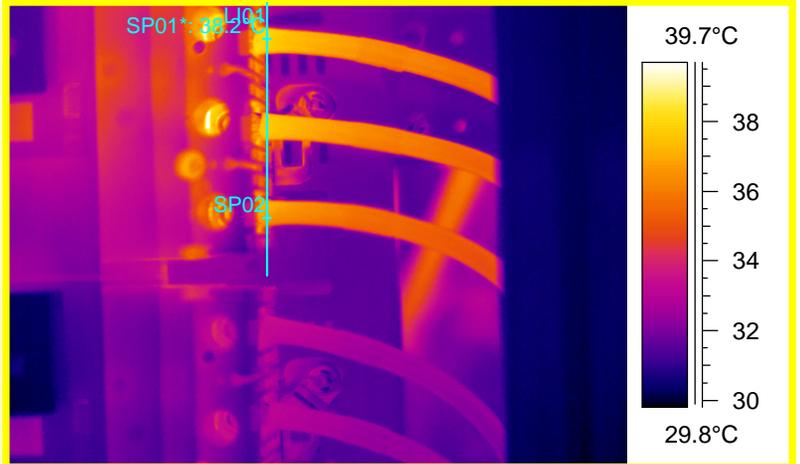
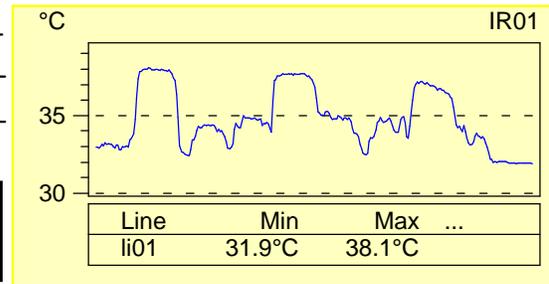
PHOTO # 0624

Exhibits a temperature rise of 1.43°C above normal.

Label	Value	Diff	Formula
SP01*	38.2°C		
SP02	36.7°C	DI01: 1.43°C	SP01 - SP02

PROBABLE CAUSE:	RECOMMENDED ACTION:	ACTION REQUIRED:
Loose Component/Connection	Secure Power	Possible deficiency; warrants investigation
Oxidation of Connection(s)	Clean and tighten connections	Probable deficiency; repair at next outage
Overloaded Circuit(s)	Determine cause of unbalance	Major deficiency; immediate action required.
Unbalanced Circuit(s)	Distribute the load more evenly	X None - Reference Only
Bad or Failing Fuse(s)	Determine the cause of overload	Repair and Verify with Infrared Scan
Bad or Failing Circuit Breaker(s)	Reduce load to below 80% of FLA	REPAIR PRIORITY RATING: 0
Code Violation	Replace Conductor(s)	
(See Engineering Report for Code Violation Description and Details)	Replace Fuse(s)	Ø
	Replace Circuit Breaker(s)	A
	Replace Bus	B
X Reference Only	X No Action Required	C

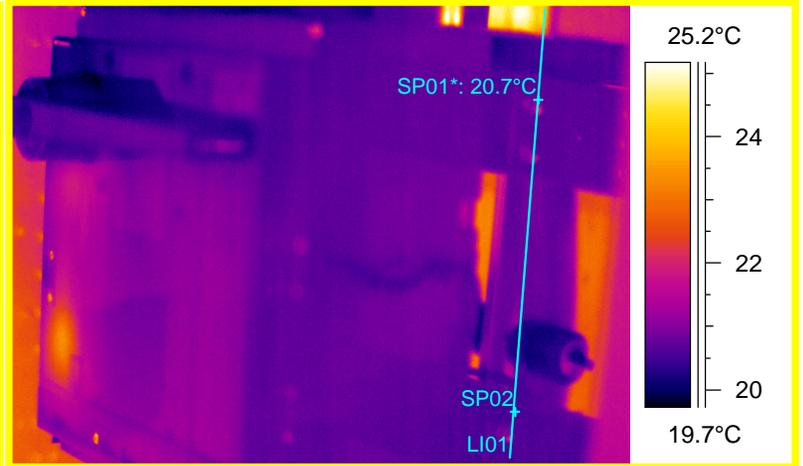
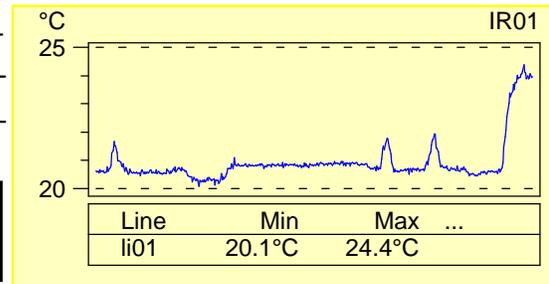
IMAGE # 0610

No deficiencies noted. Images for reference only.

Exhibits a temperature rise of 0.15°C above normal.

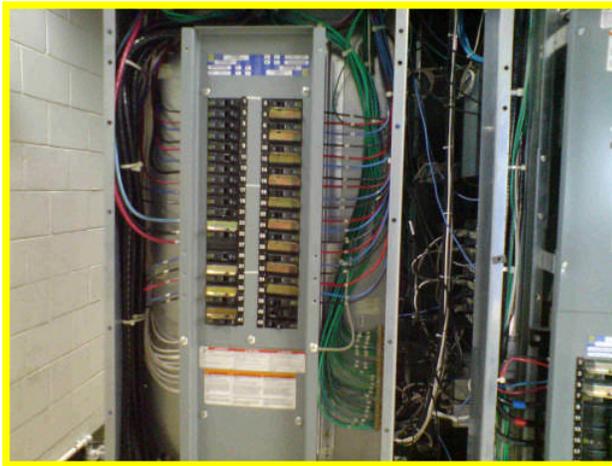
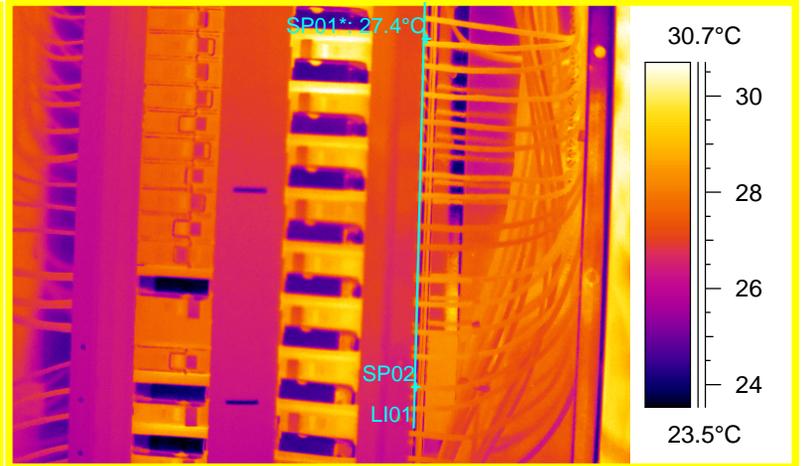
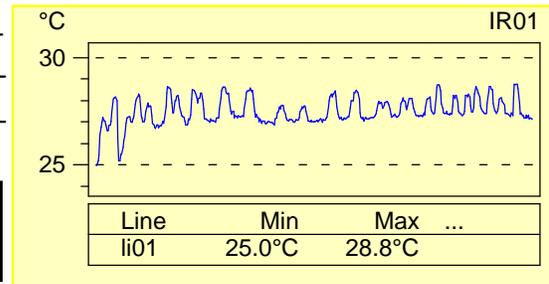
PHOTO # 0607

No deficiencies noted. Images for reference only.

Exhibits a temperature rise of -0.85°C above normal.

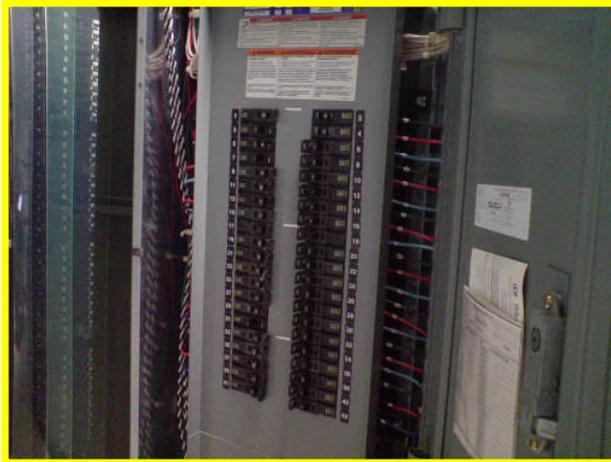
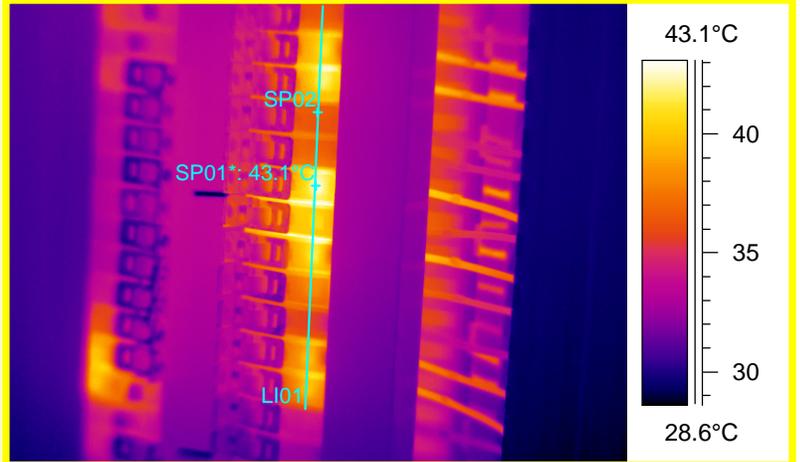
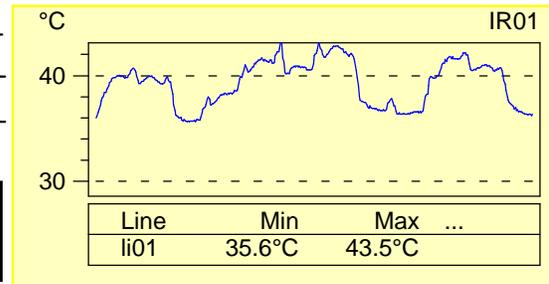
PHOTO # 0609

No deficiencies noted. Images for reference only. Variances in temperatures of the breakers can be contributed to variances in load.

Exhibits a temperature rise of 6.61°C above normal.

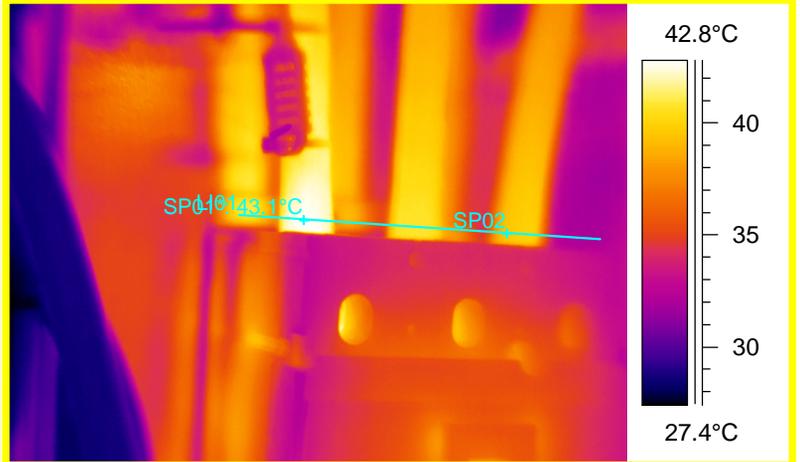
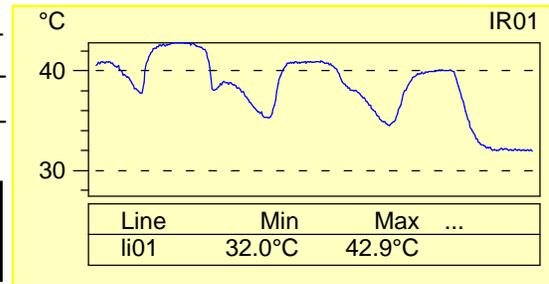
IMAGE # 0620

A Phase is exhibiting elevated temperature consistent with a loose or dirty connection. We recommend cleaning & re-torquing the connection.

Exhibits a temperature rise of 3.43°C above normal.

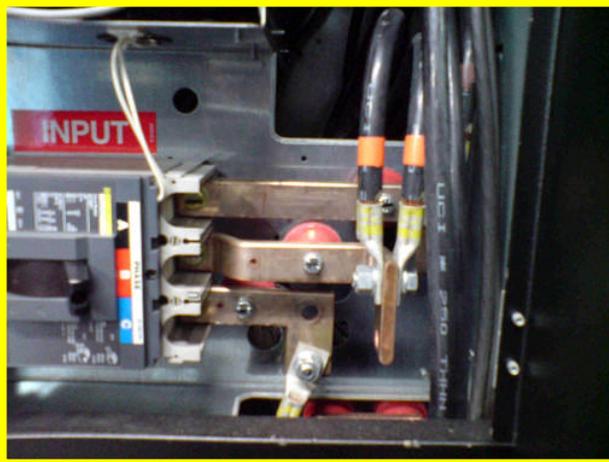
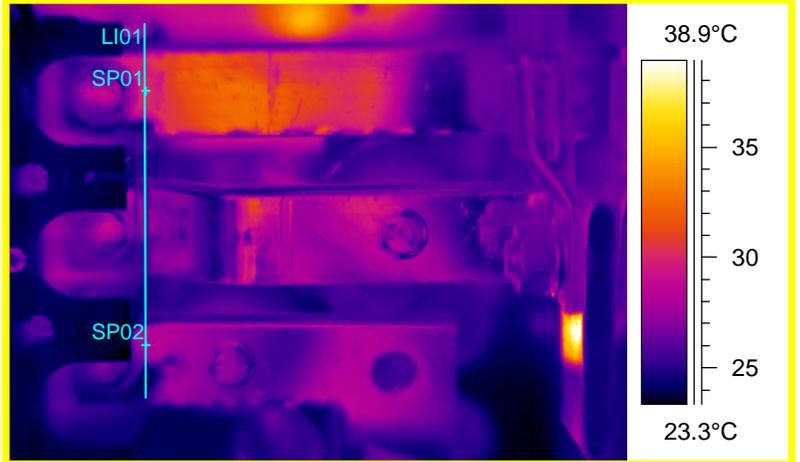
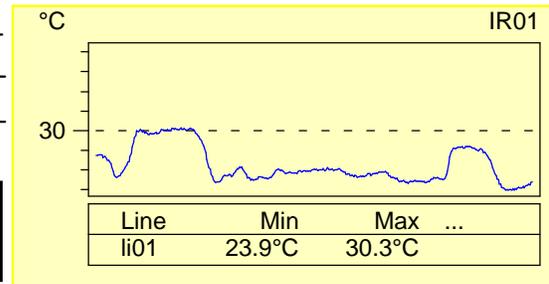
PHOTO # 0627

No deficiencies noted. Images for reference only.

Exhibits a temperature rise of 1.74°C above normal.

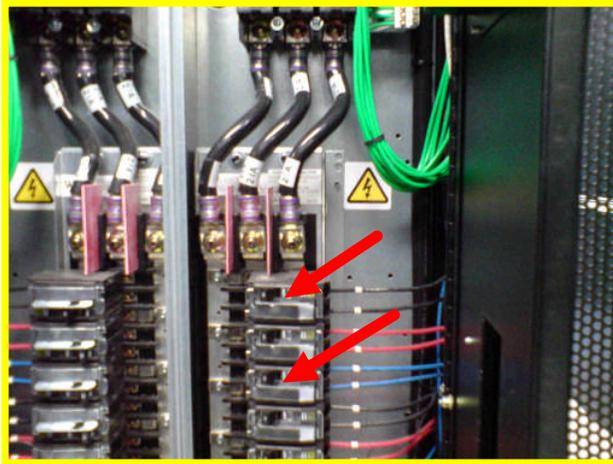
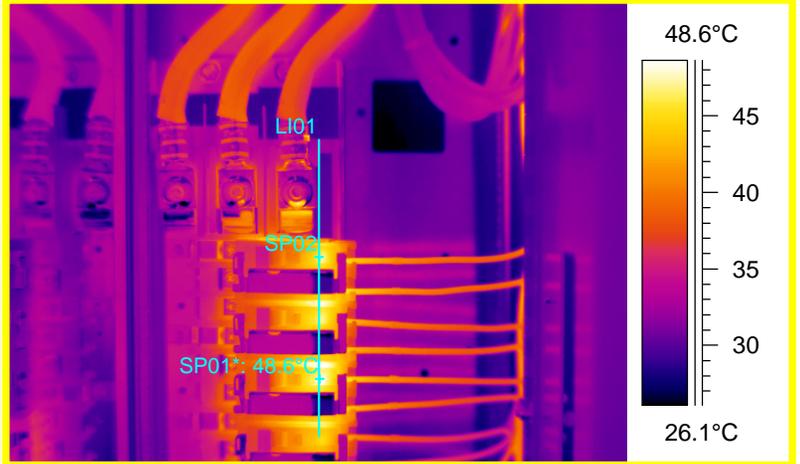
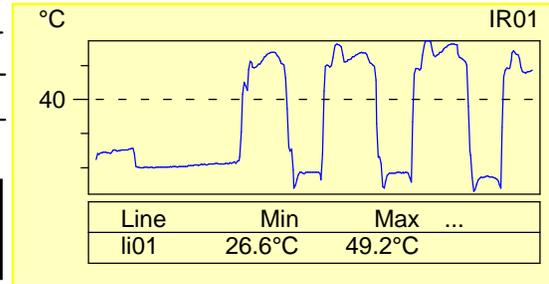
PHOTO # 0626

No deficiencies noted. Images for reference only.

Exhibits a temperature rise of 1.84°C above normal.

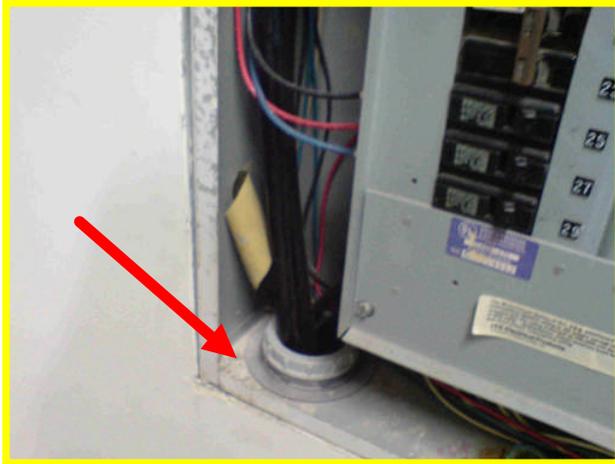
PHOTO # 0598

Dirt and debris found in the bottom of the panel. Clean panel.

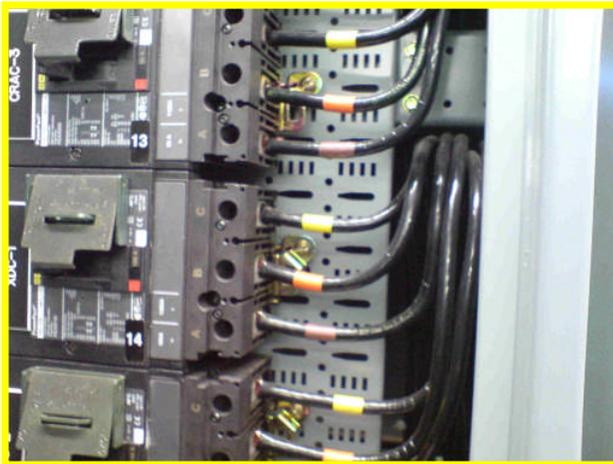
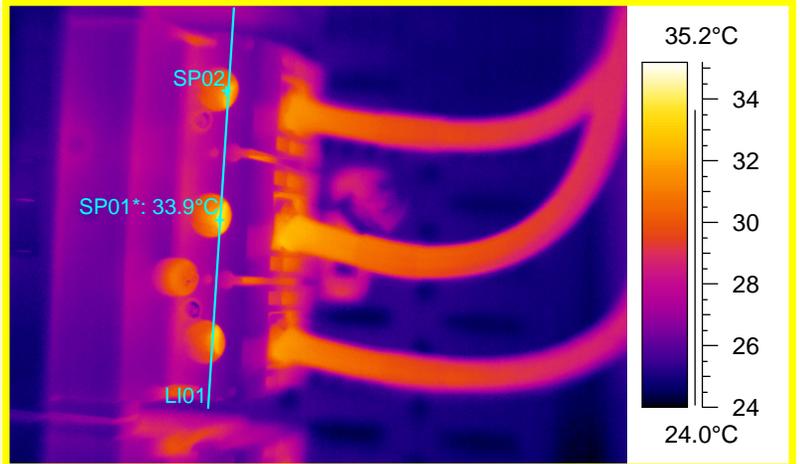
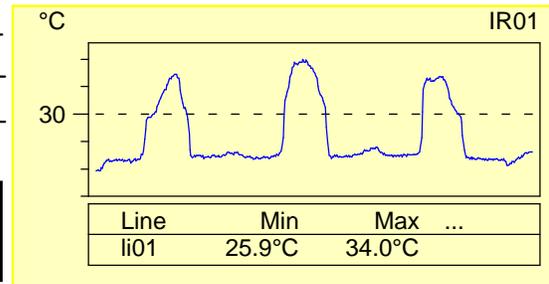
PHOTO # 0601

No deficiencies noted. Images for reference only.

Exhibits a temperature rise of 1.64°C above normal.

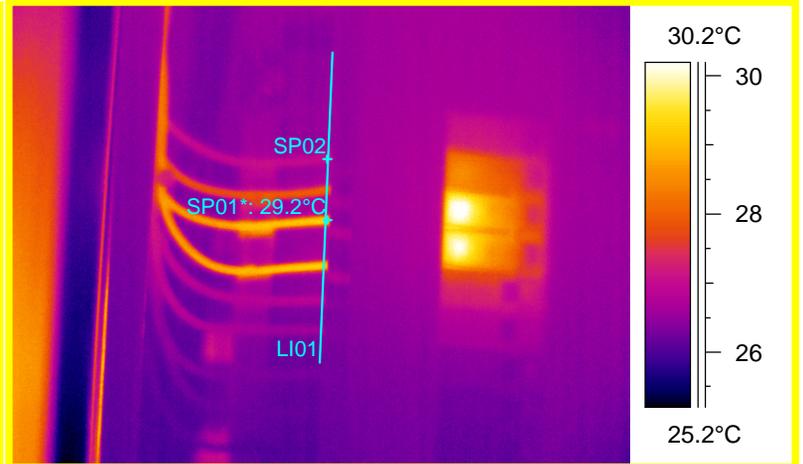
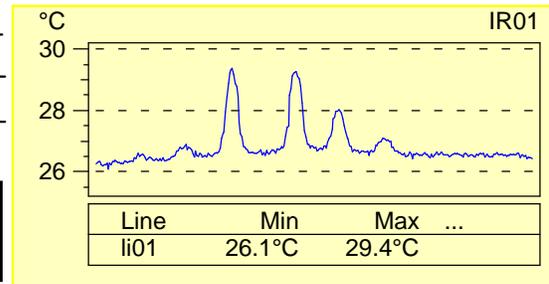
PHOTO # 0603

No deficiencies noted. Images for reference only.

Exhibits a temperature rise of 2.20°C above normal.

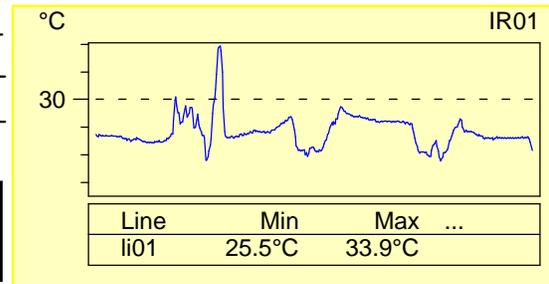
Unbalanced load. Investigate to determine the cause of the unbalance and distribute the load more evenly.

Exhibits a temperature rise of 7.73°C above normal.
